REPORT ON CEILING ISSUES& POSSIBLE SKYHYDRANT AT MATERNITY WARD AT BALIBO HOSPITAL

BACKGROUND

The Balibo House Trust requested me to inspect possible roof leaks and mould at the Maternity Ward at the Balibo Hospital, and the possibility of installing a SkyHydrant water supply system.

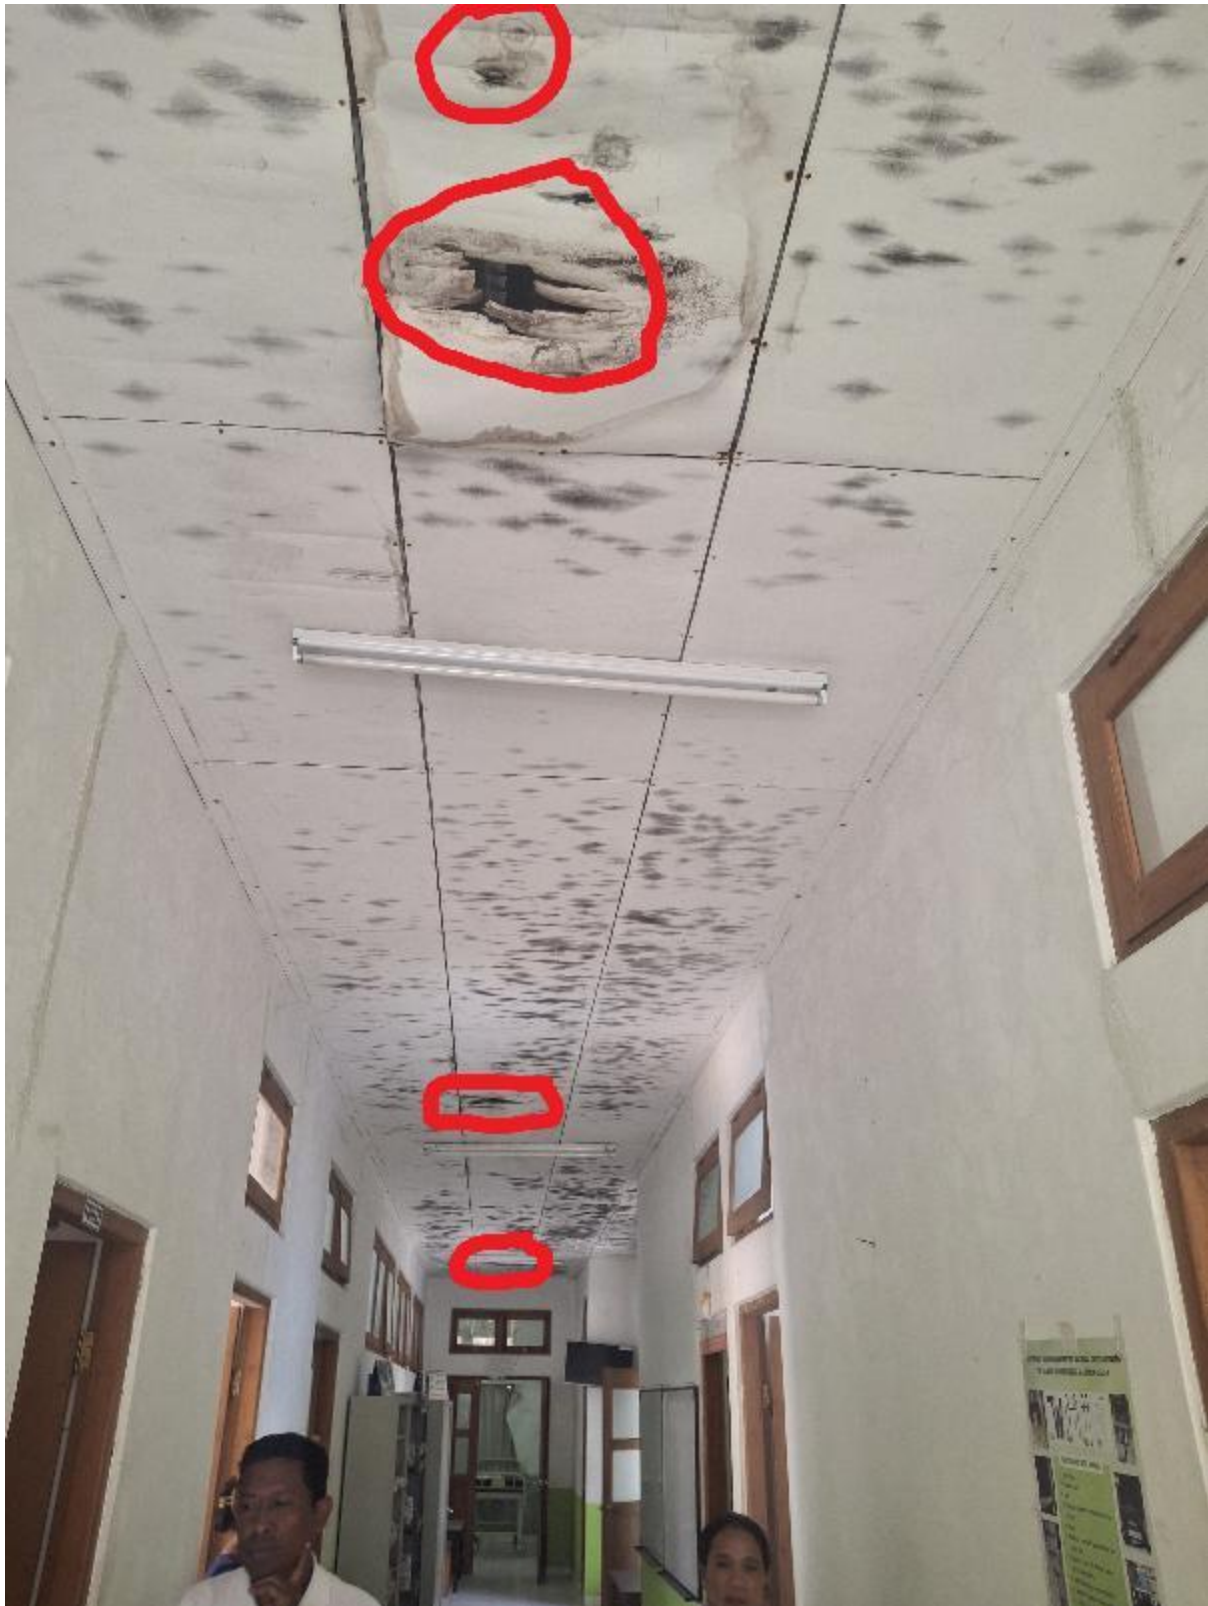
Photo along the central hallway showing the black mould and several areas of water damage (indicated by the red circles). The water damage along the hallway indicates that water is entering via the central part of the roof line – ie the ridge capping area.

Combined with the building alignment, any prevailing wind-driven rain simply splashes under the ridge capping. The water damaged ceilings along the centreline of the building are evidence that the rainwater is entering along the ridgeline of the roof.

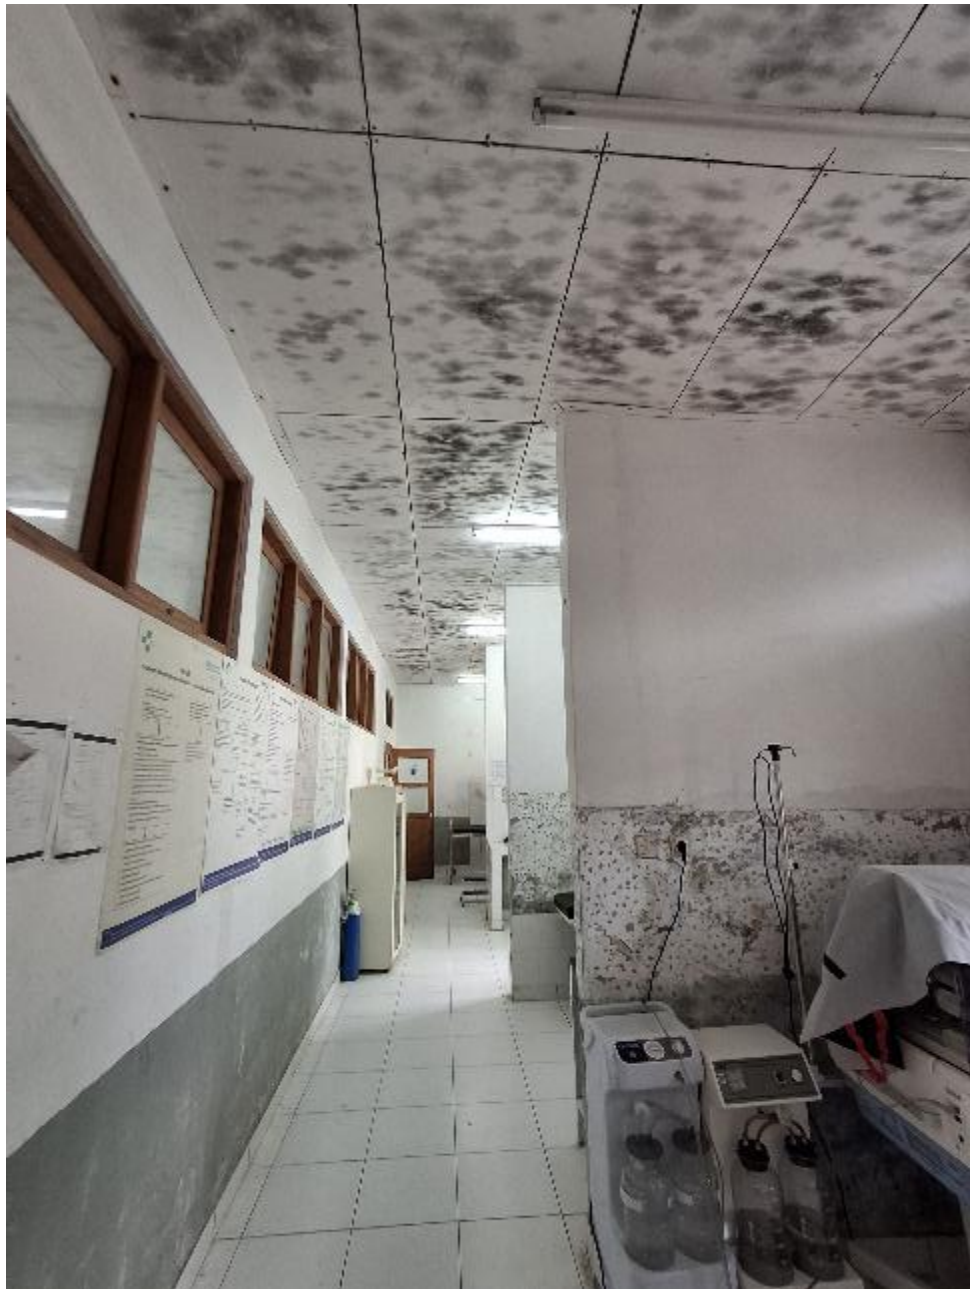
*Black mould through the actual birthing rooms.
Tiles fallen off the lower parts of the walls.*

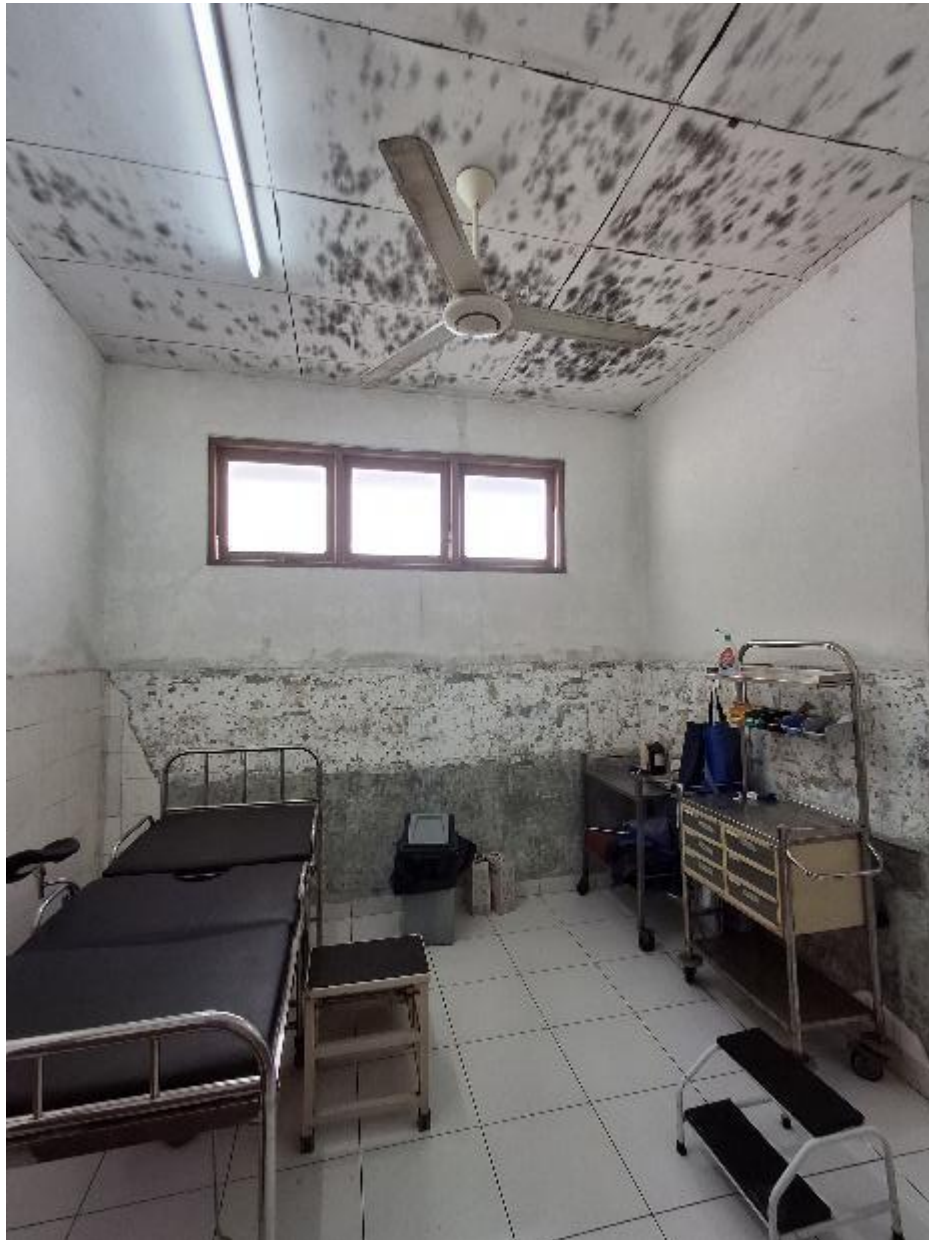
One of the birthing rooms. Most tiles have fallen off the walls (some tiles remaining in the left corner). "New" birthing bed!

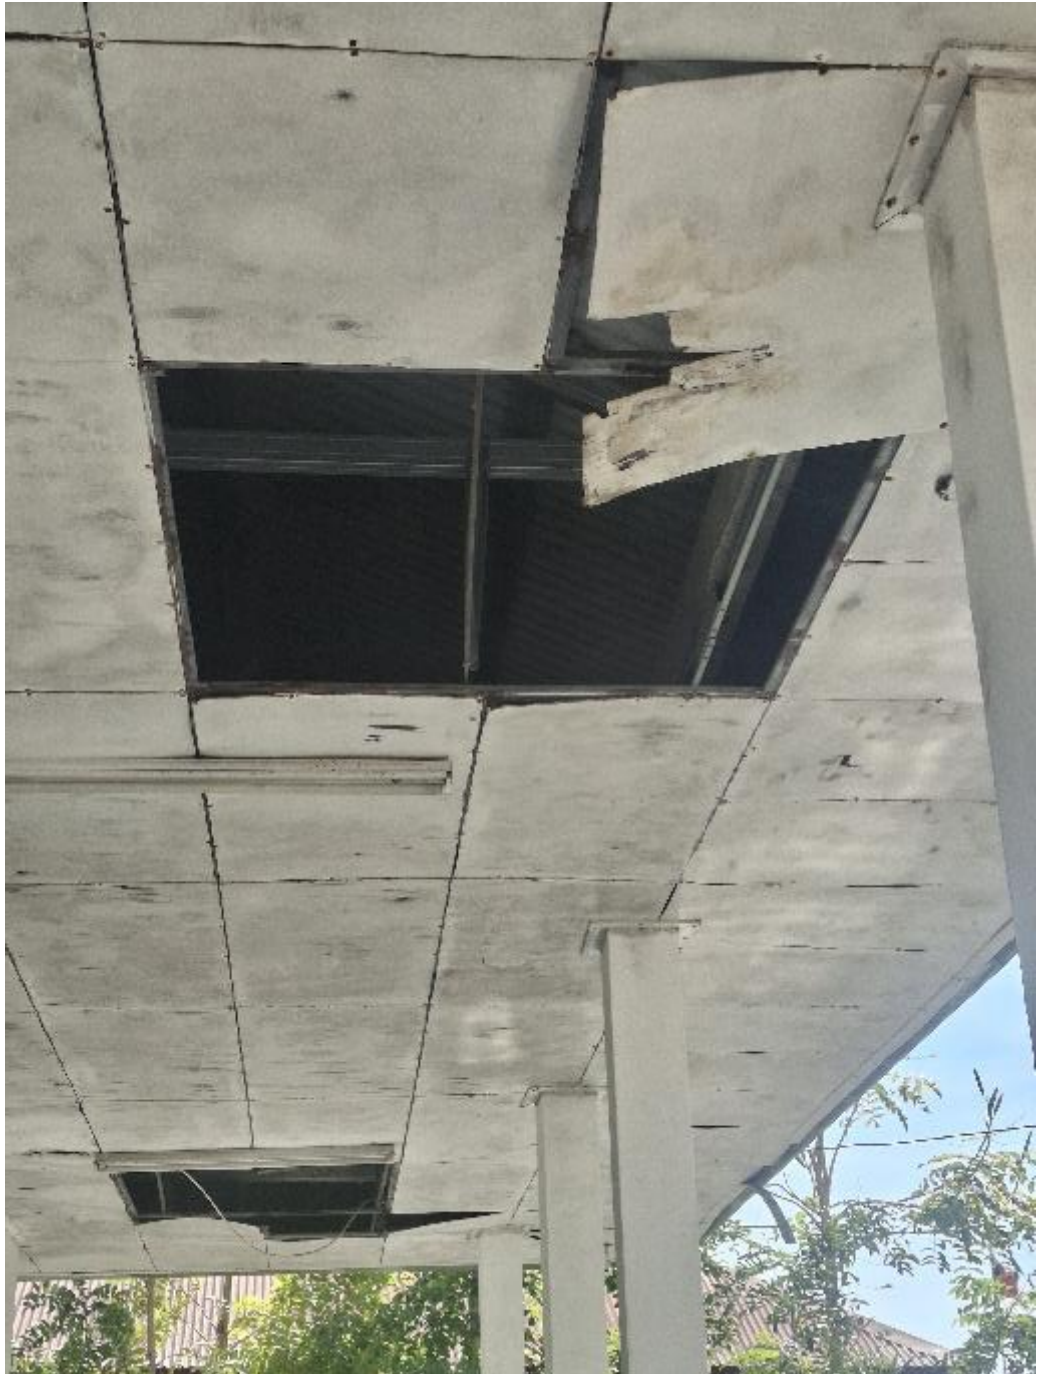
External ceilings badly water damaged, with the damage below the sloping ridge lines.

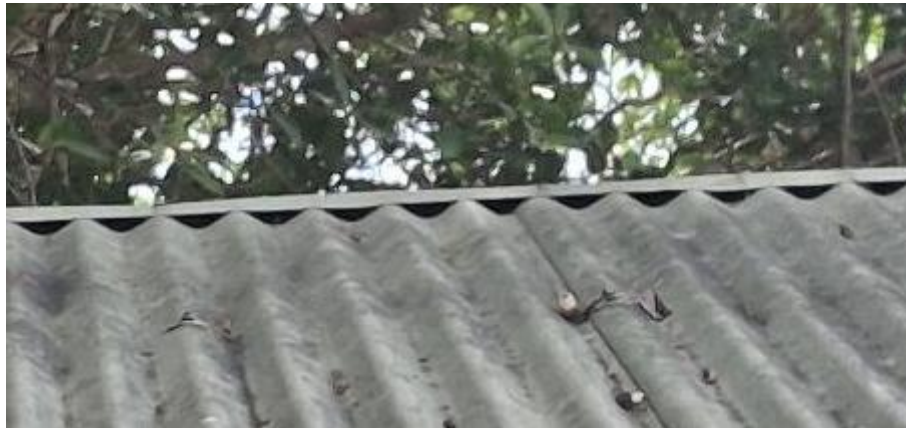
The ridge capping has been laid along each of the roof ridges, but the capping has not been notched to fit into the roofing corrugations.

Photo of existing ridge capping

A hand operated notching tool matching the corrugations of the roof is available.

The distance between corrugations was 75mm, if a notching tool was to be purchased.

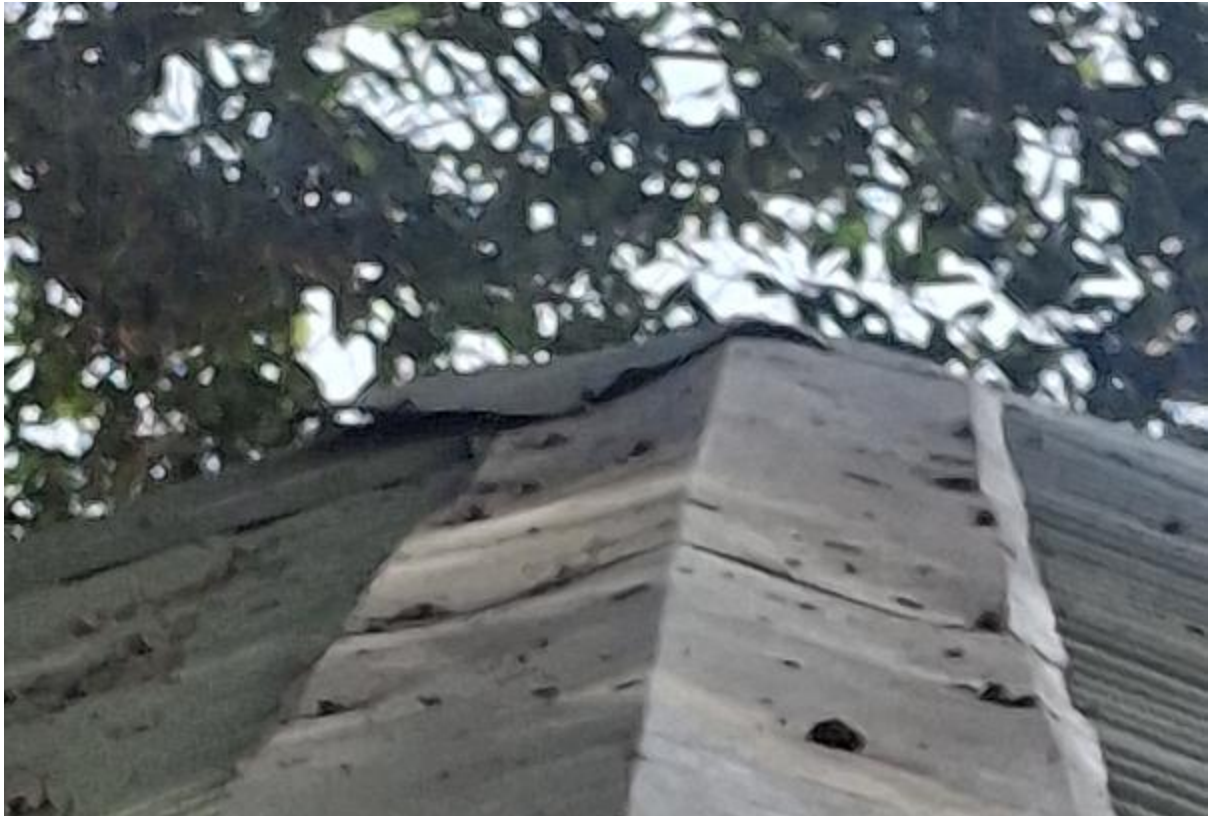
There were a couple of areas where the ridge capping was not fully secured down, which would allow water penetration.

Photo showing ridge capping not secured down.

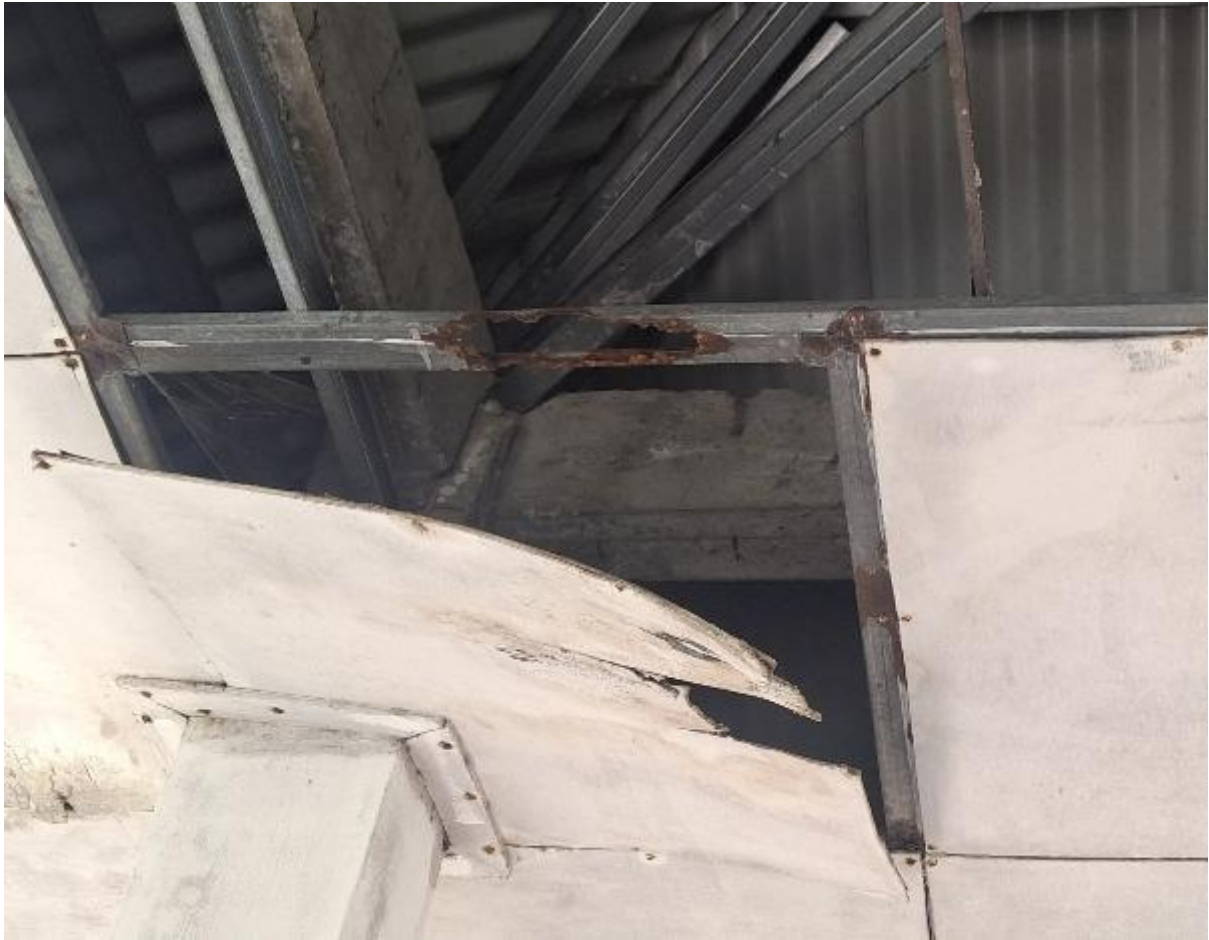
It was noted that some of the ceiling battens (to which the ceiling material is attached), have significant rust.

Ceiling batten (to which ceiling sheets are screwed) almost completely rusted away. Note that the actual roof sheeting (not the ceiling sheeting) looks in good condition.

It is recommended that all battens are inspected and replaced where necessary when the ceiling material is replaced. Knowing that many of the battens are rusted, it would be wise to pre-purchase say 10% of the total required battens, so that ceiling replacement work could continue while additional battens were purchased, if required.

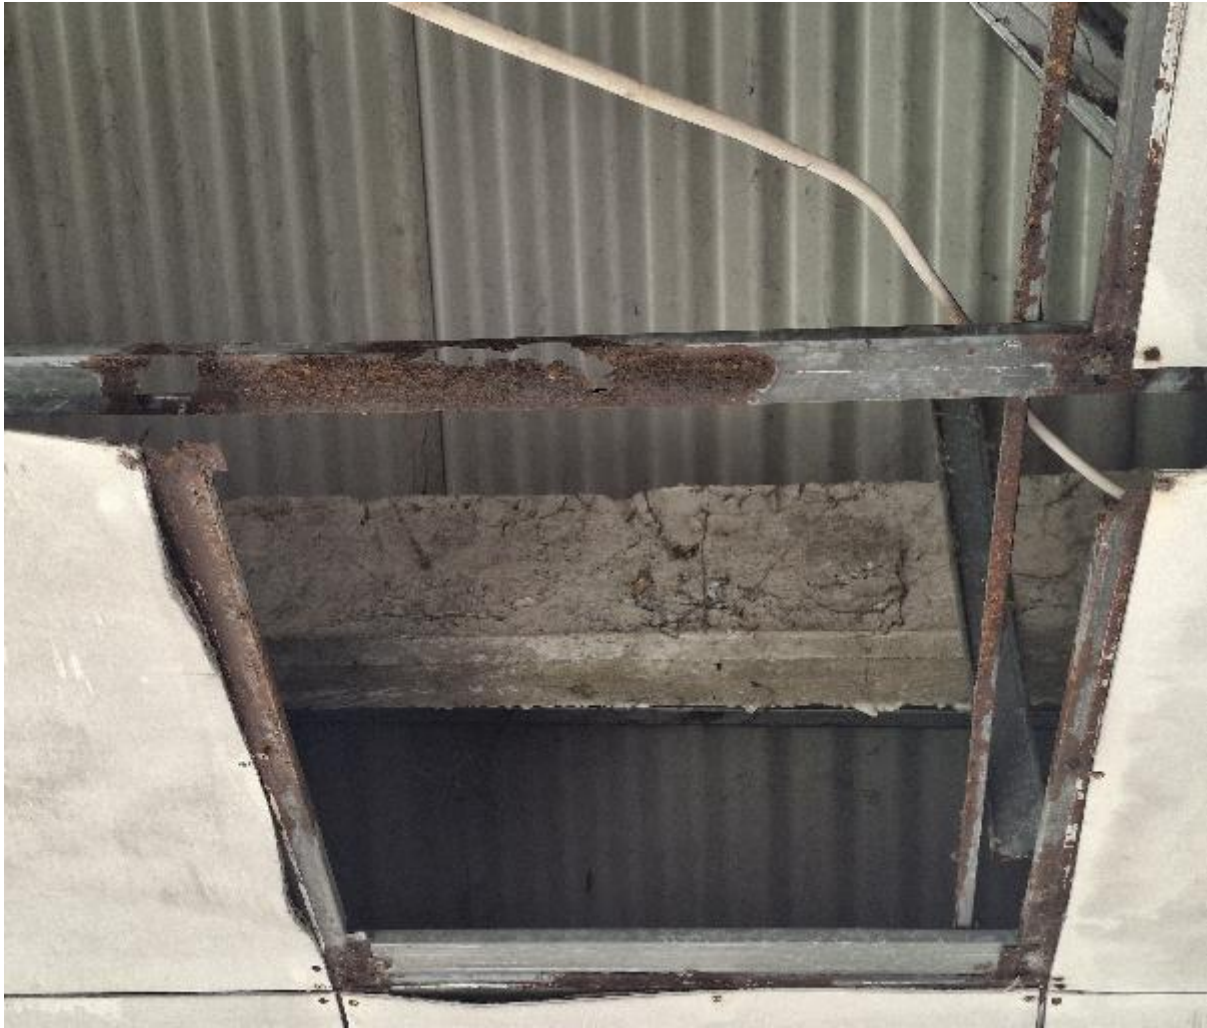
*And again – ceiling batten badly rusted.
The quality of the concrete beam is suspect with all the crack lines through it.*

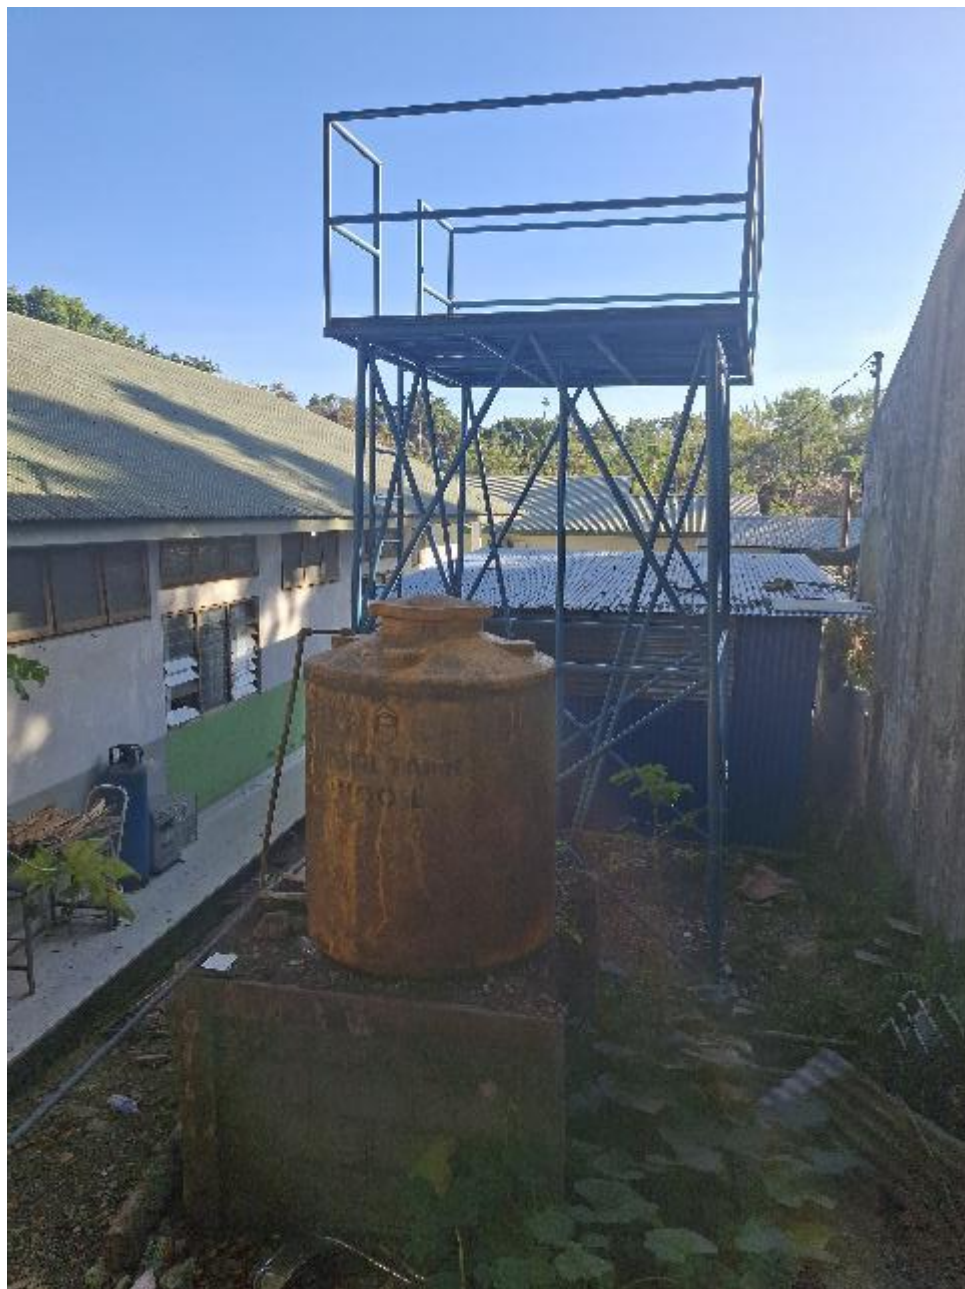
There is an existing, unused tank stand of about 4m in height. It is in good condition and appears to have been well constructed. It could be used to hold a “dirty water” tank.

Adjacent to the tank stand is an old, unused Profile tank of 1,100 L capacity. It is sitting on a concrete tank stand, which will provide sufficient height to enable water to be gravity fed to the maternity ward. This tank could possibly be cleaned and used as the “clean water” tank.

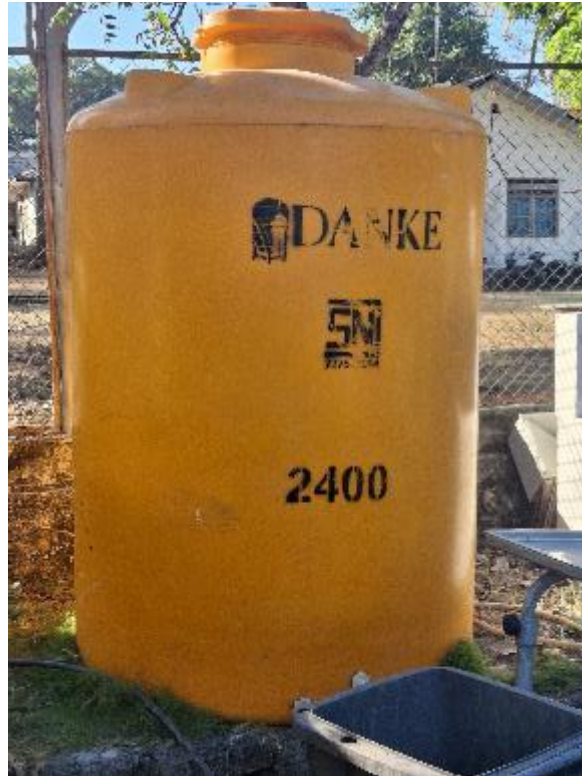
Apparently under-utilised 2,400L Danke tank

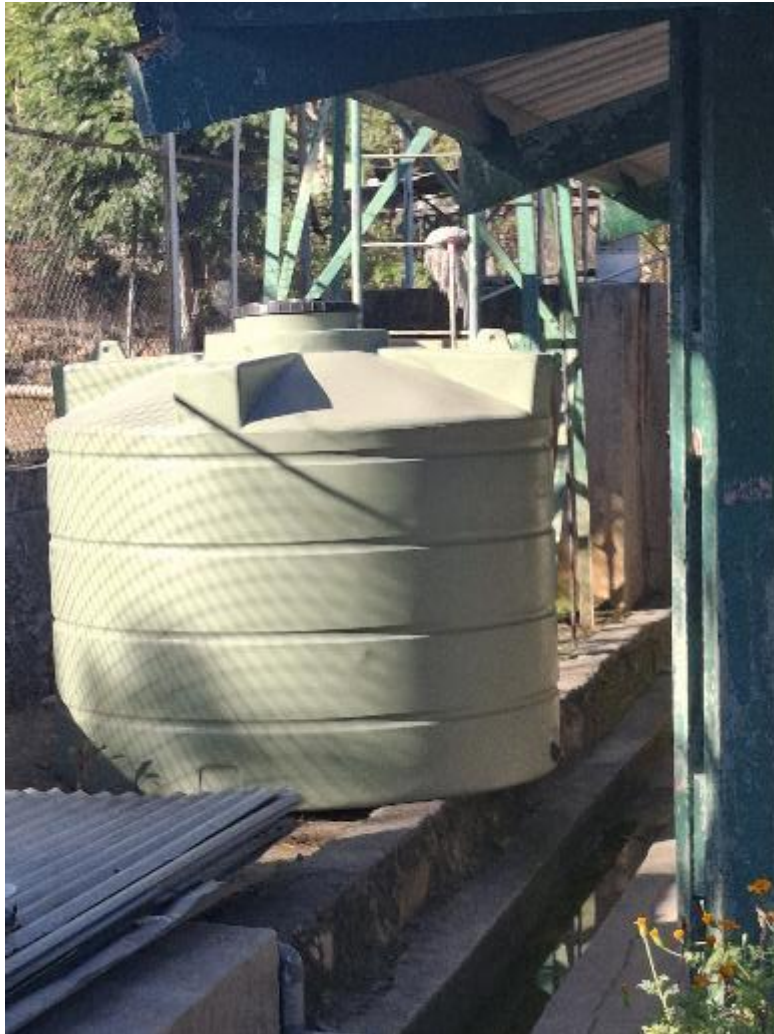
Unused 3,200L Rotomold tank

This Rotomold tank could be used as the dirty water tank.
