## REPORT ON LOTAN WATER SUPPLY

Herein is a photographic report on the Lotan water supply project.

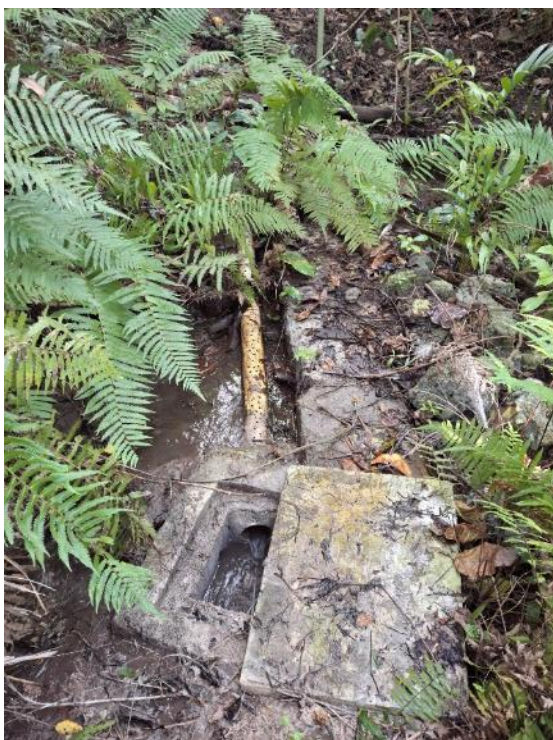
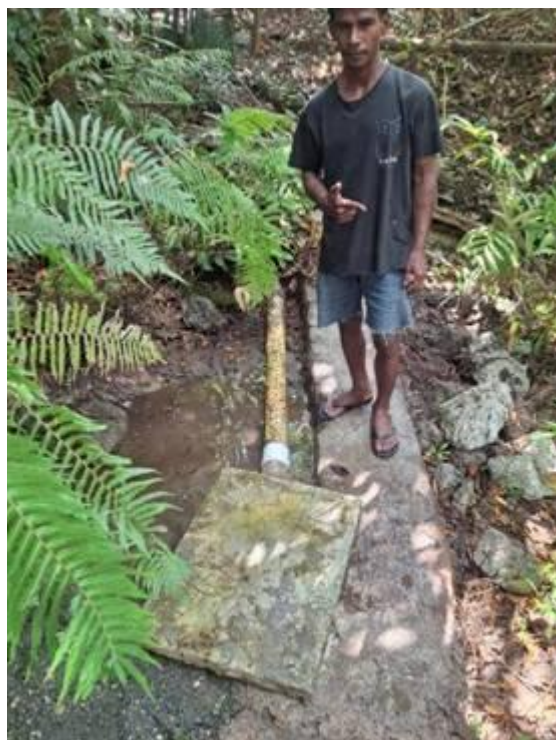
*Before & after photos. Lid correctly placed, white pipe joiner clamped over large hole that was allowing leaves etc to enter, and lots of holes drilled into the yellow pipe to allow water entry (but no leaves). The holes in the pipe had closed over due to mineral deposit build up.*

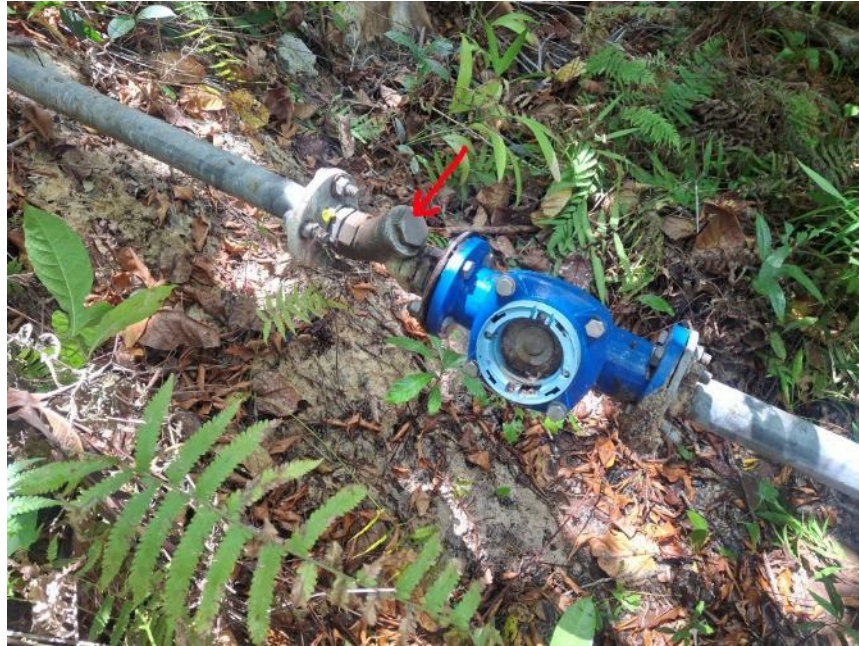
*The in line filter cleaned out of much rubbish of leaves & twigs.  
(The filter is contained under the large bronze nut indicated by the arrow)*

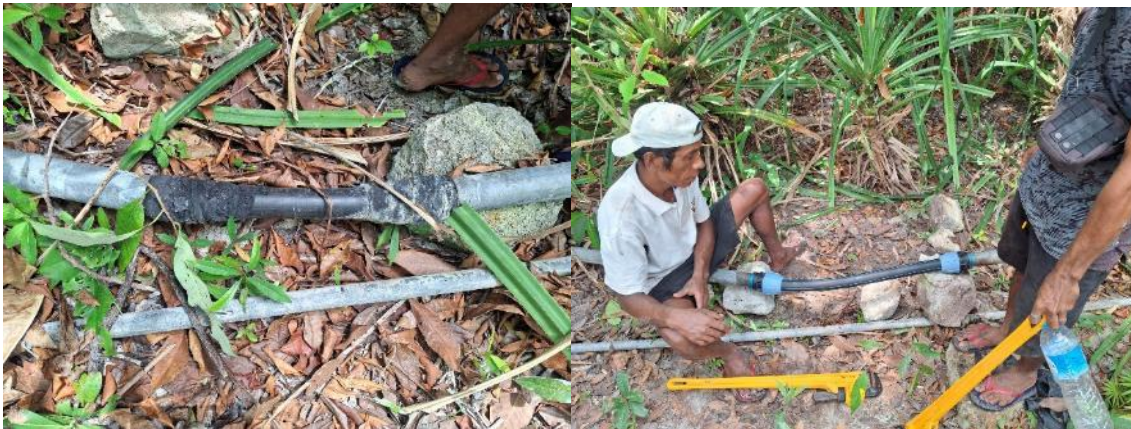
*Before and after shots.*

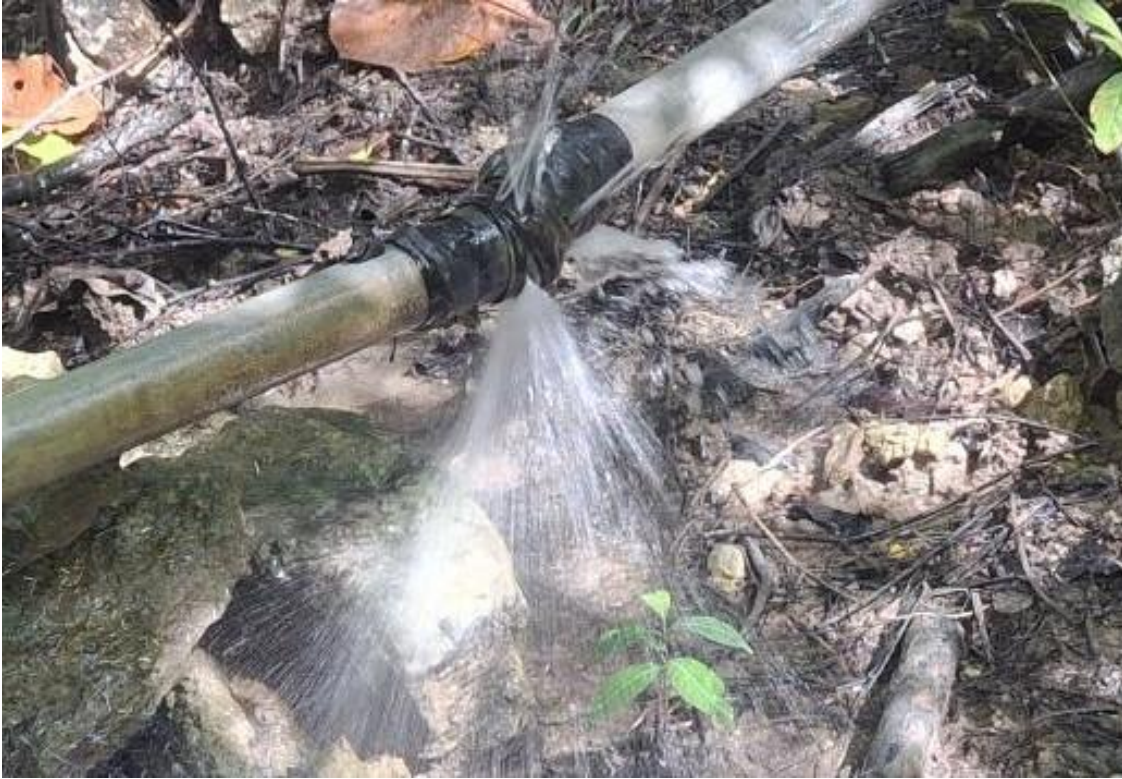
*Typical issue: major leak - pipes not correctly aligned; joint broken; rubber innertube binding not effective.*

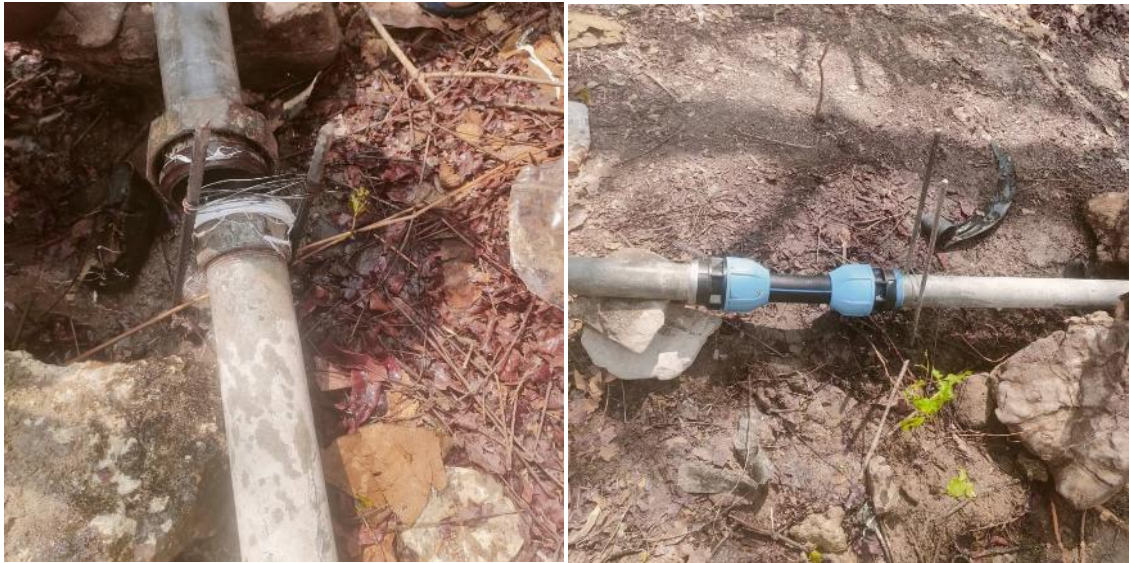
*Failed barrel union. All old union components removed, pipe threads repaired, new fittings and pipe installed.*

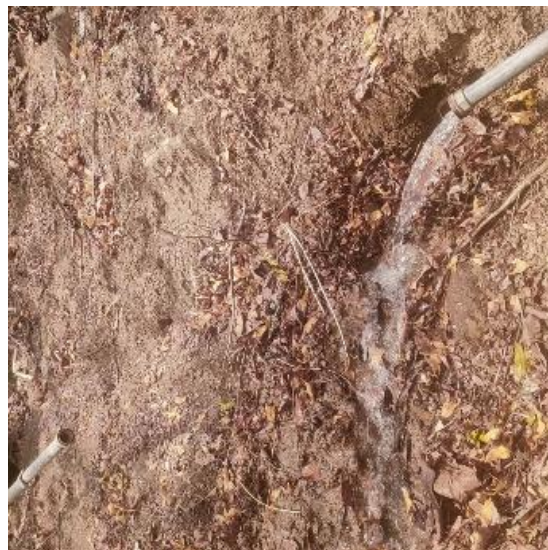
*Near-vertical section of hill, pipes not correctly aligned; joint broken, pipes slid apart.*

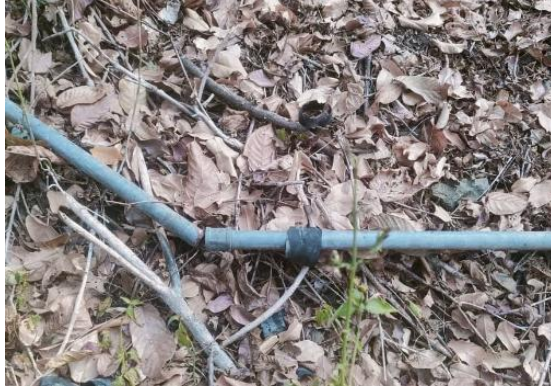
*No wonder this joint broke, with the angle of the pipes and hence the strain on the joint.*

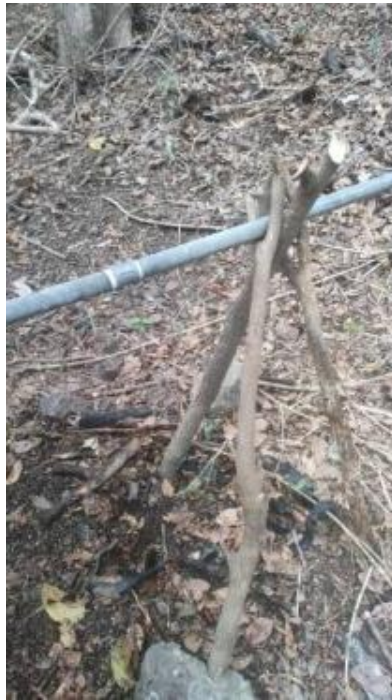
*A joint repaired and supported.*

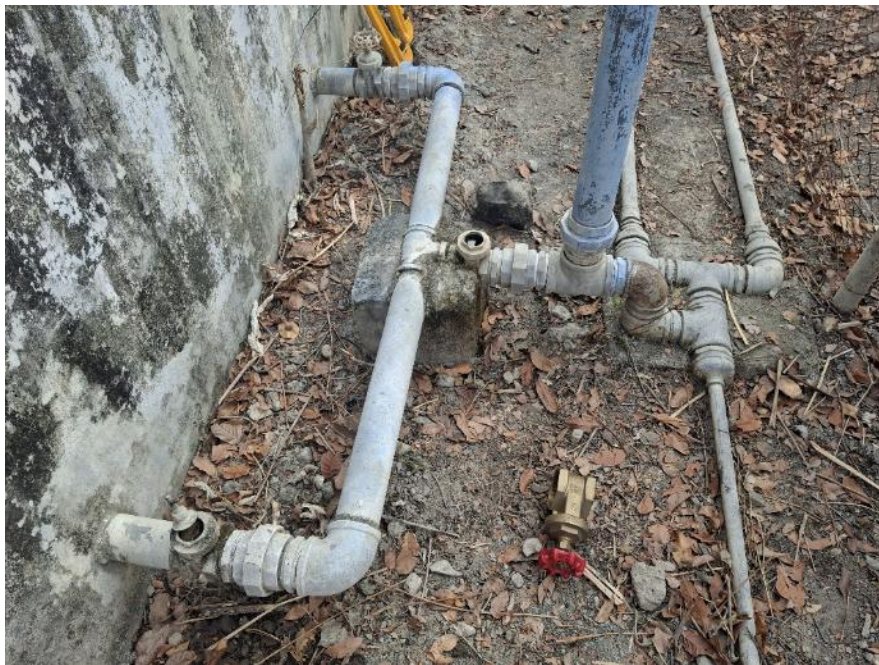
*This is the exit pipe network from big tank. Note two of the gate valve tap-heads are broken.*

We hoped to use the tap-head from the new gate valves (visible on the ground), but the tap-head sizes were different. We ended up scavenging one tap-head from an unused section of the big tank, and Rino took the other tap-head to Maliana and had it bronze welded

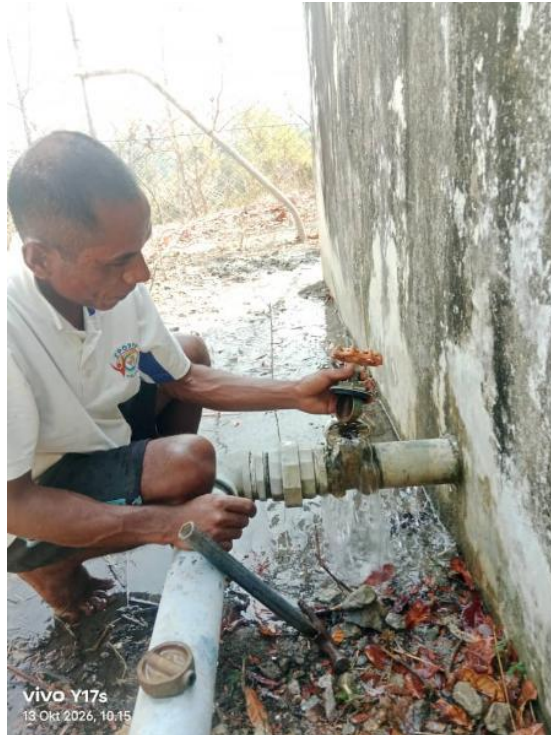
*Water pouring out of gate valve with broken tap-head.*

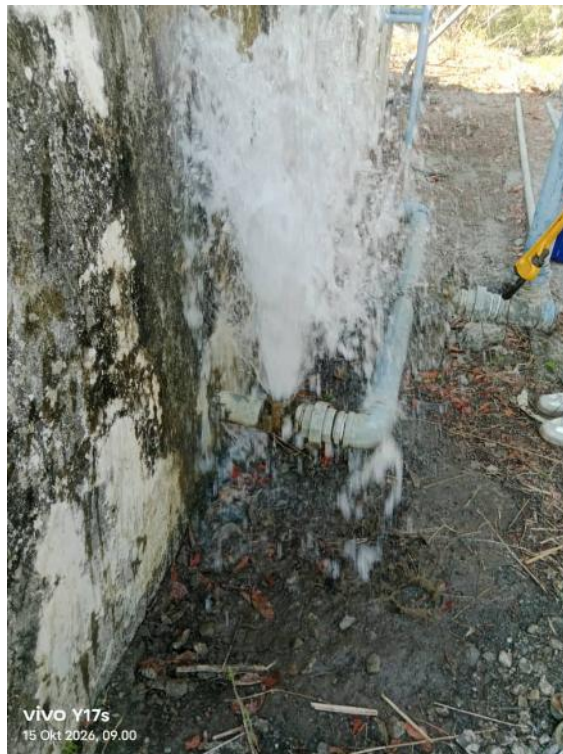
*Attempting to install the welded tap-head. Water shooting out of the gate valve – proof the big tank was filling.*

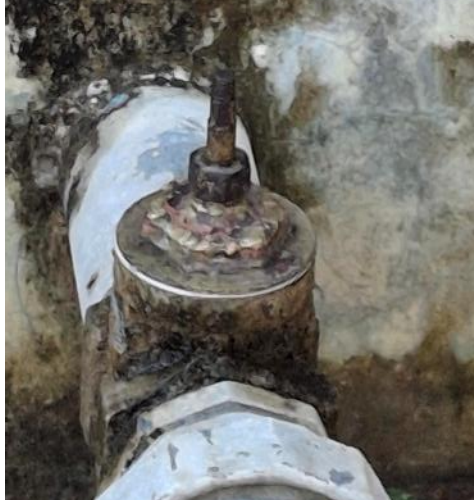
*Welded tap-head installed – no leaks!*

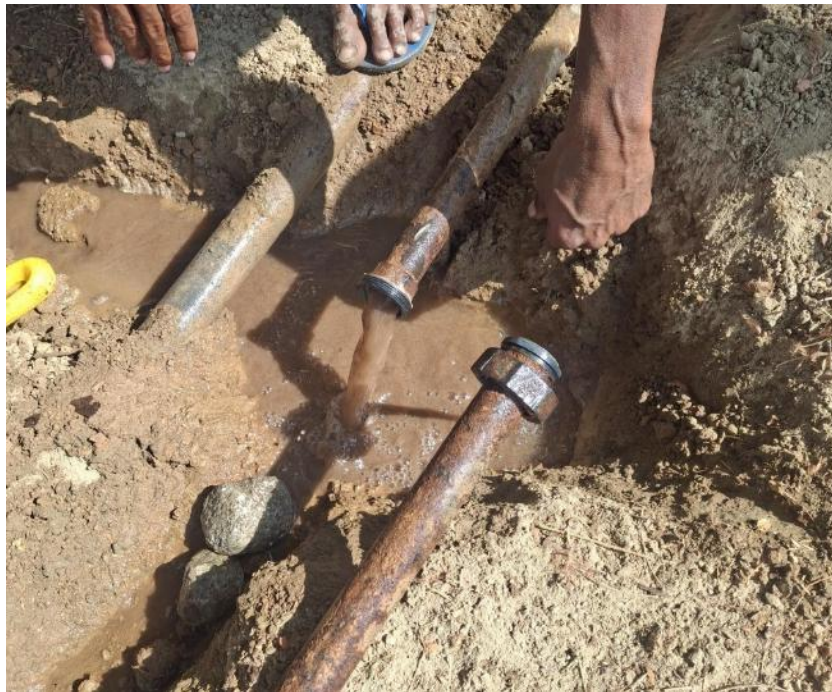
*Supply pipe from big tank located and opened at barrel union (joiner).  
Note the degree of dirt coming from the pipe.*

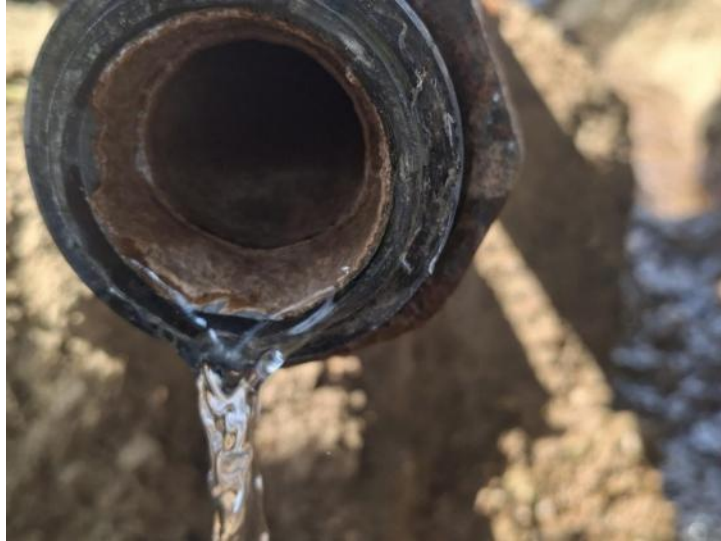
*Very low flow coming from the pipe further towards village, due to scale and build up in pipe. Intermediate barrel unions could not be accessed and/or opened due to the depth on one, and some 4 tonnes of gravel over another.*

There was a very low flow from the existing 1 ½" gal pipe, so the decision was made to run new 50mm poly pipe (pipe and fittings were already held at Belola container) from near the large tank to the village, and new 32mm pipe (pipe purchased; most fittings held) run through the village to the aerial ropeway and further through the village.

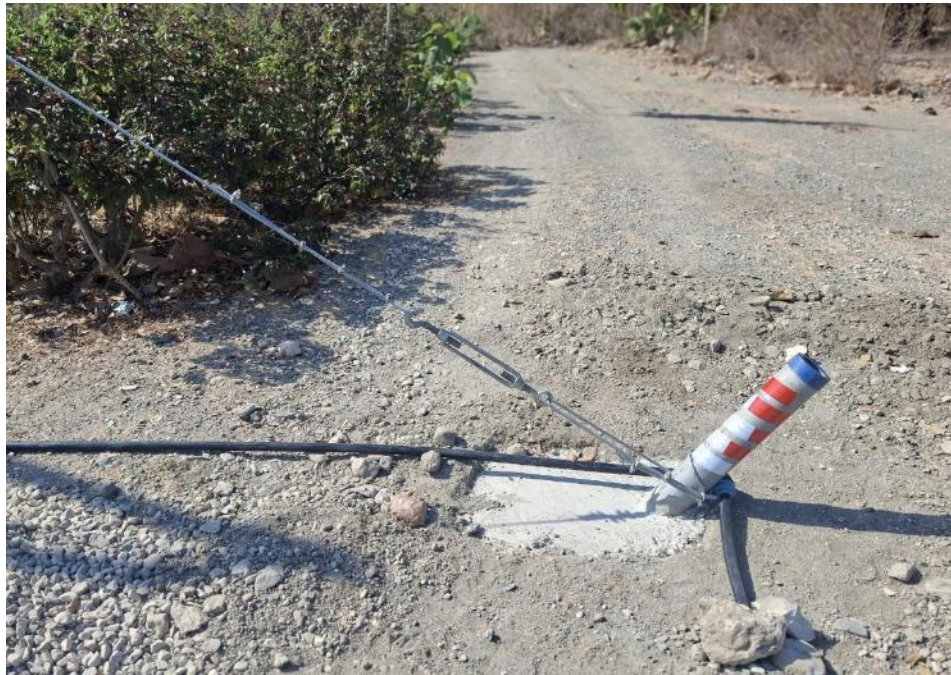
*The western bank anchorage.*

*The reflective tape was applied as the anchorage protruded into the little-used "roadway".  
Rocks also placed around the anchorage to keep vehicles away.*

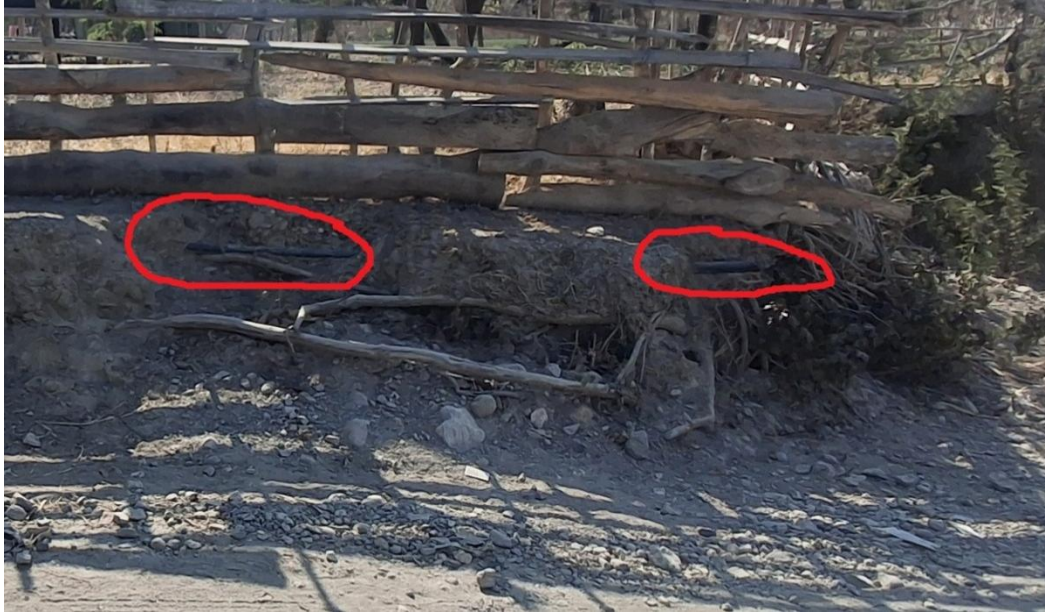
*Old pipe on western bank – exposed and torn apart by flooded river. This was the only section found in the 600m from the aerial ropeway! (Red ovals show ends of the pipe)*

This required us to install 600m of new 32mm poly pipe from the aerial ropeway to the first section we could locate of the old pipe.

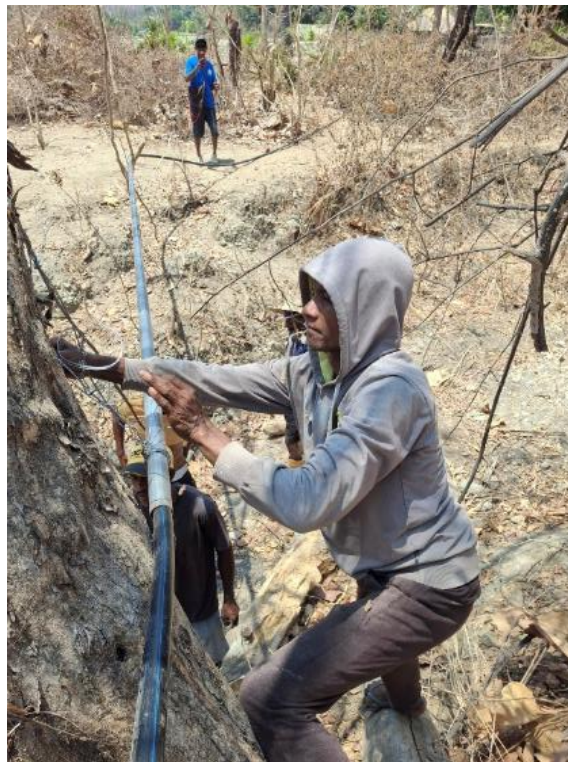
*32mm poly pipe encased in a gal pipe for strength, and suspended well above a creek on the western bank.*
