REPORT ON CEILING ISSUES& POSSIBLE SKYHYDRANT AT MATERNITY WARD AT BALIBO HOSPITAL

BACKGROUND

The Balibo House Trust requested me to inspect possible roof leaks and mould at the Maternity Ward at the Balibo Hospital, and the possibility of installing a SkyHydrant water supply system.

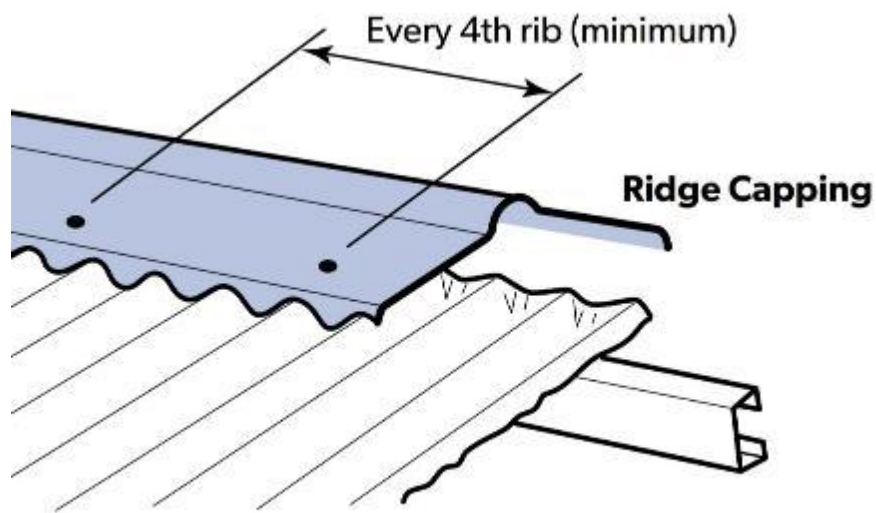
Diagram showing how ridge capping should be notched over corrugations

A hand operated notching tool matching the corrugations of the roof is available.

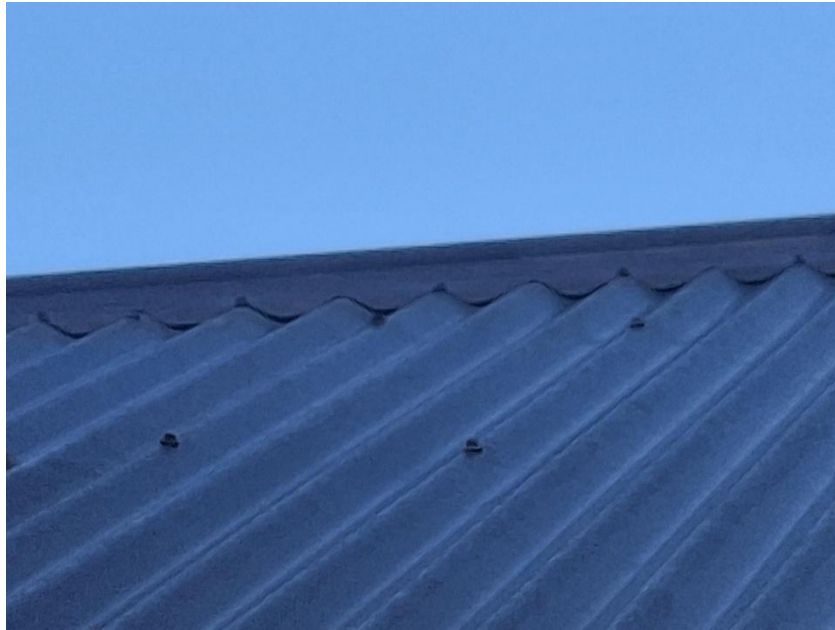
*Photo of how the ridge capping should be finished,
with the notching completed.*

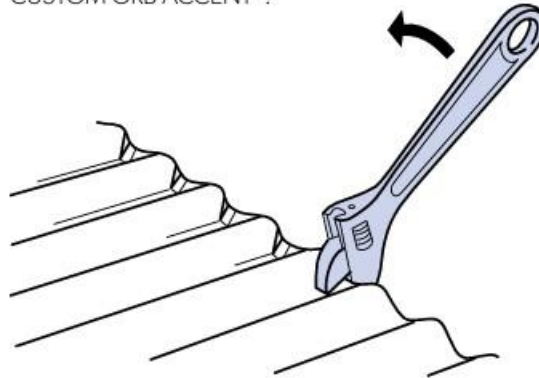
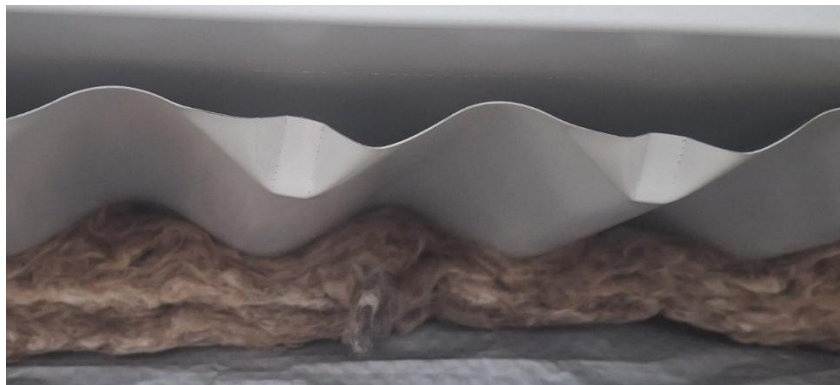
FIGURE 10.1.2:

Turning-up CUSTOM ORB®, CUSTOM BLUE ORB® and CUSTOM ORB ACCENT®.

Photo showing the ends of roofing sheets that have been “turned up”.

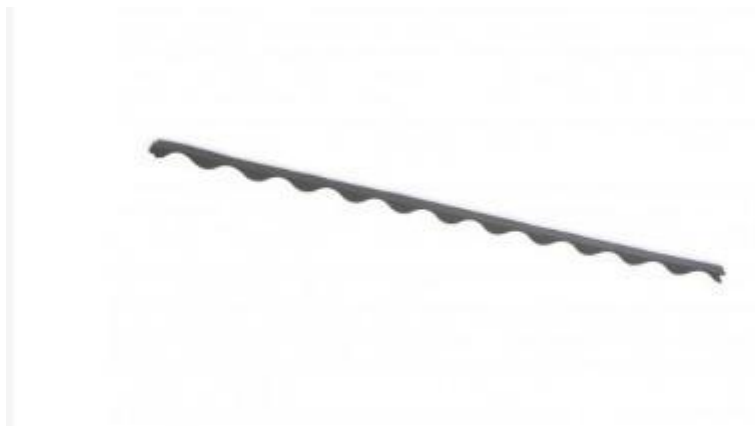
Expanded foam strips can be installed under the ridge capping at the upper end of the roof sheets. Expanded foam strips seal off gaps between roofing and ridge capping – protecting against dust, wind, rain and pests.

Photo of foam strips
