## REPORT ON LOTAN WATER SUPPLY

Herein is a photographic report on the Lotan water supply project.

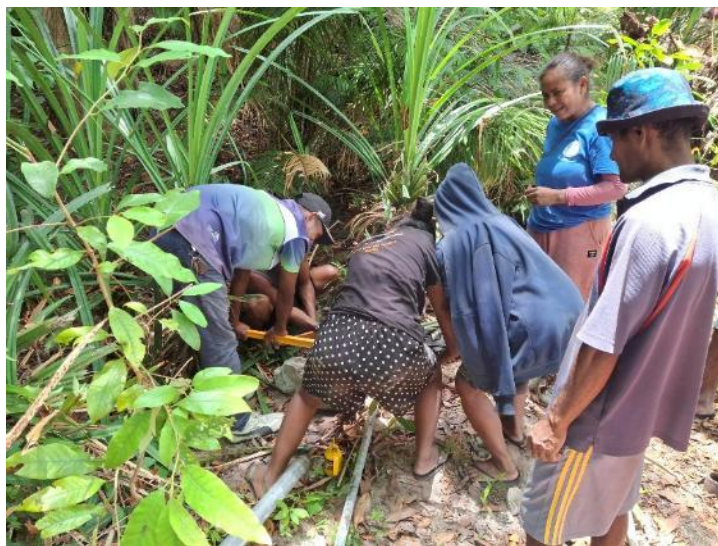
Cutting or repairing the pipe threads with a large thread cutter:

*Hard work, but they worked well together. Syska supervising.*

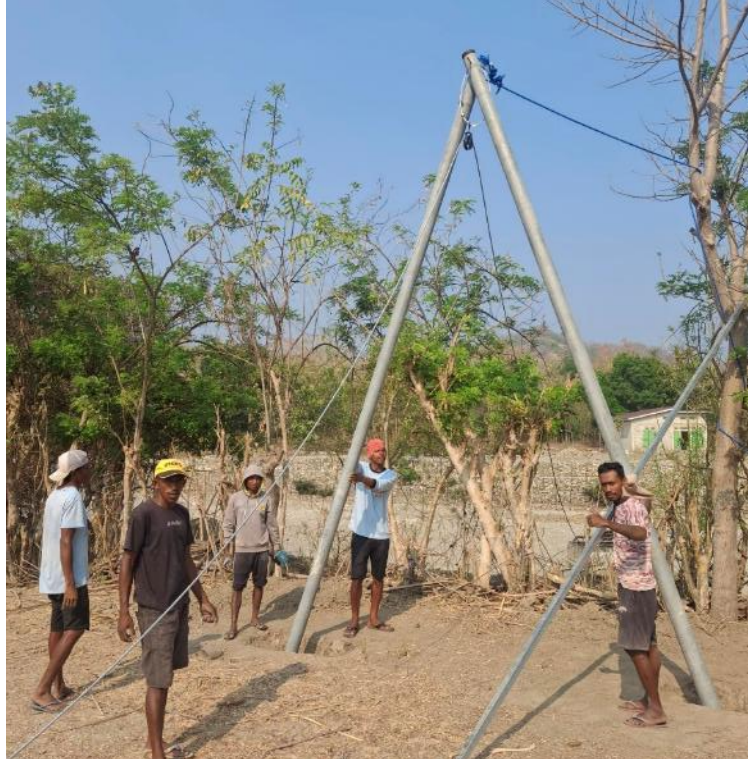
*Support structure on the eastern bank raised and inserted into holes ready for concreting. (Legs are 100mm diameter x 6m long steel pipes.) Steel wire rope ready-run through top pulley.*

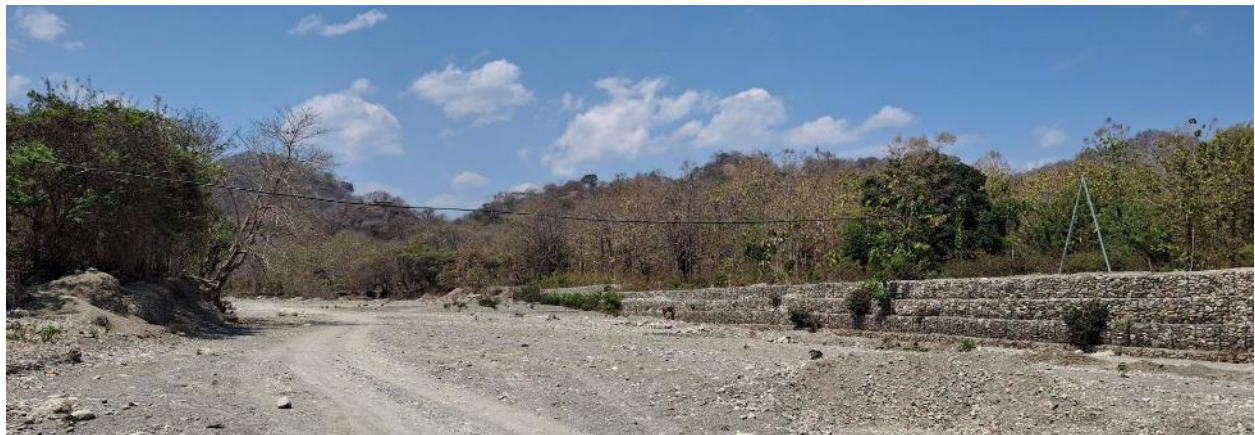
*The ropeway erected, with poly pipe attached below it. 5m (+) above river bed.*

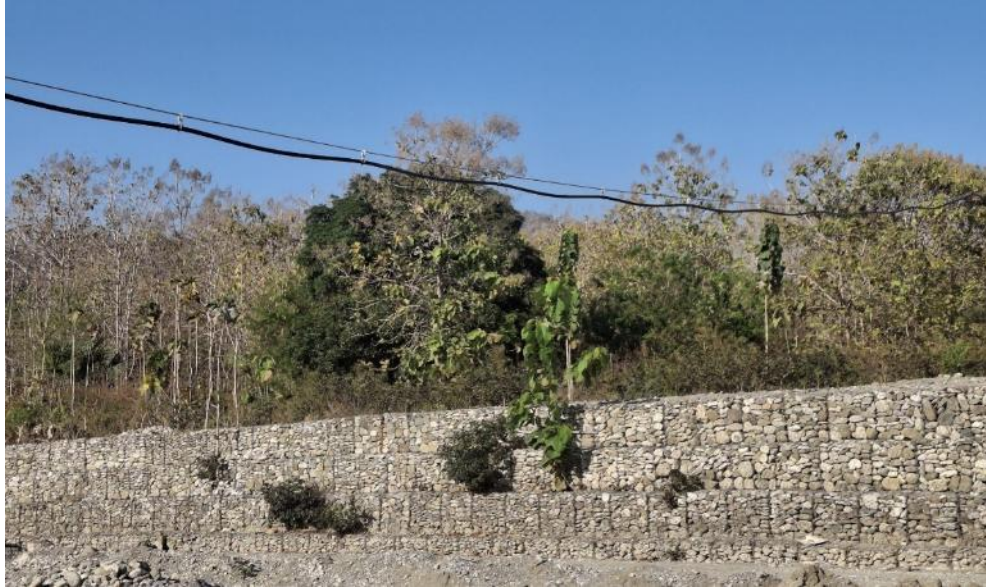
*The poly pipe suspended below the steel wire rope.*

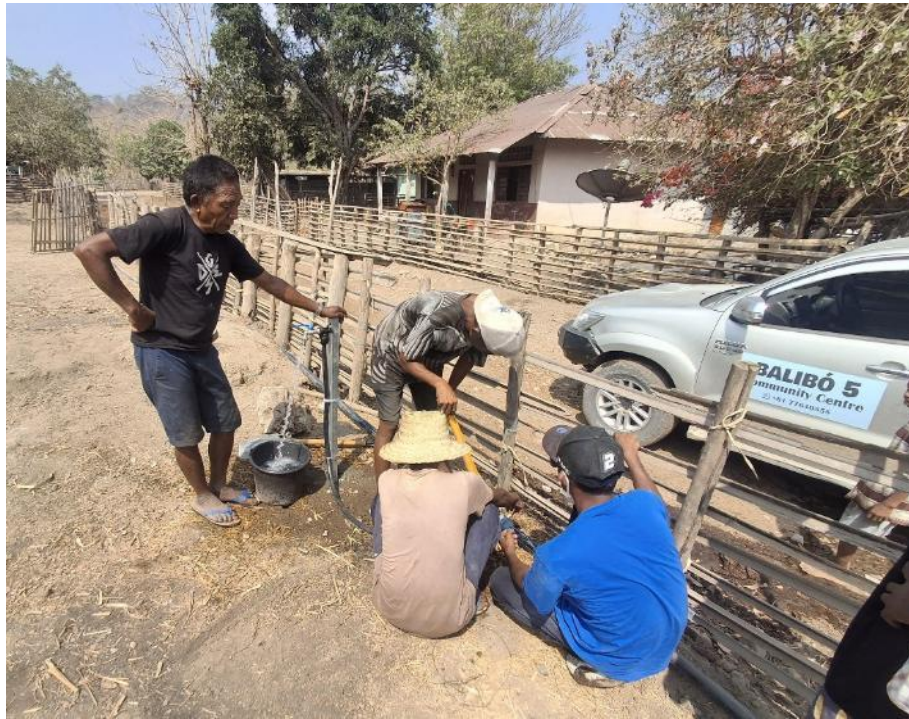
*First tap installed in the village. We had not even finished installing it, and it was already being used. Happy villagers! Mario showing the workers how to install the fittings.*

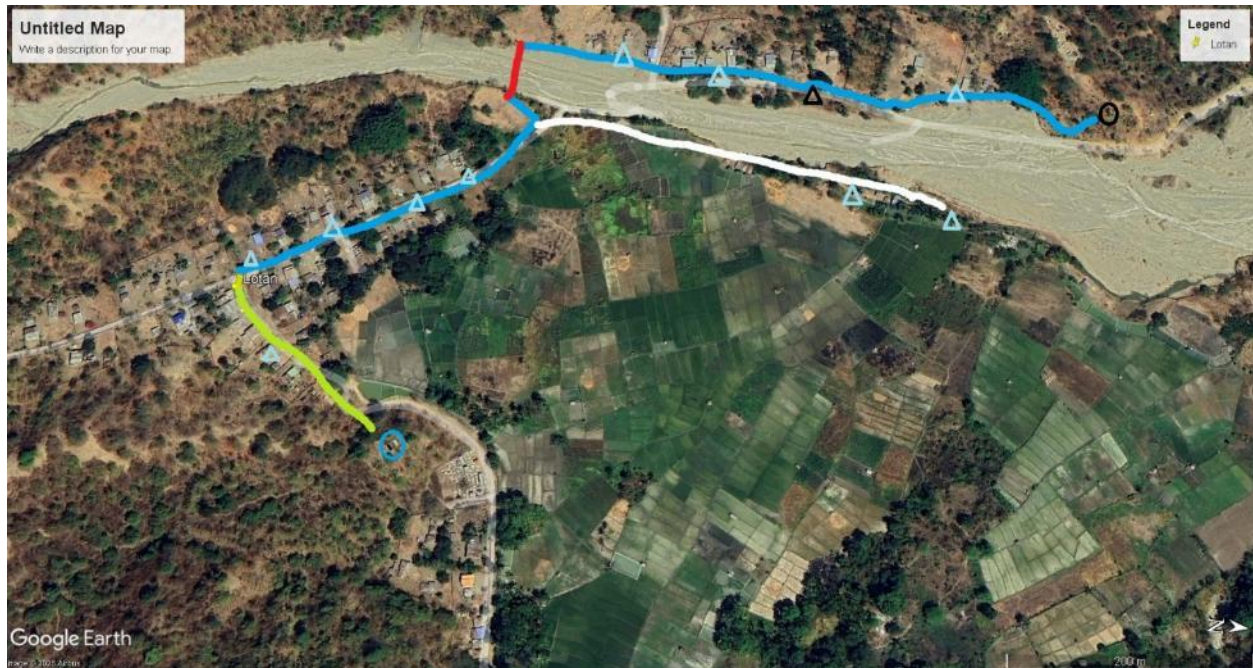
Central section of village marked by yellow pin at centre left of photo.
