REPORT ON CONSTRUCTION OF WATER SYSTEM AT BALIBO CLC

AUGUST 2025

Following is a brief pictorial report on the construction of the water supply system at Balibo CLC in Timor-Leste.

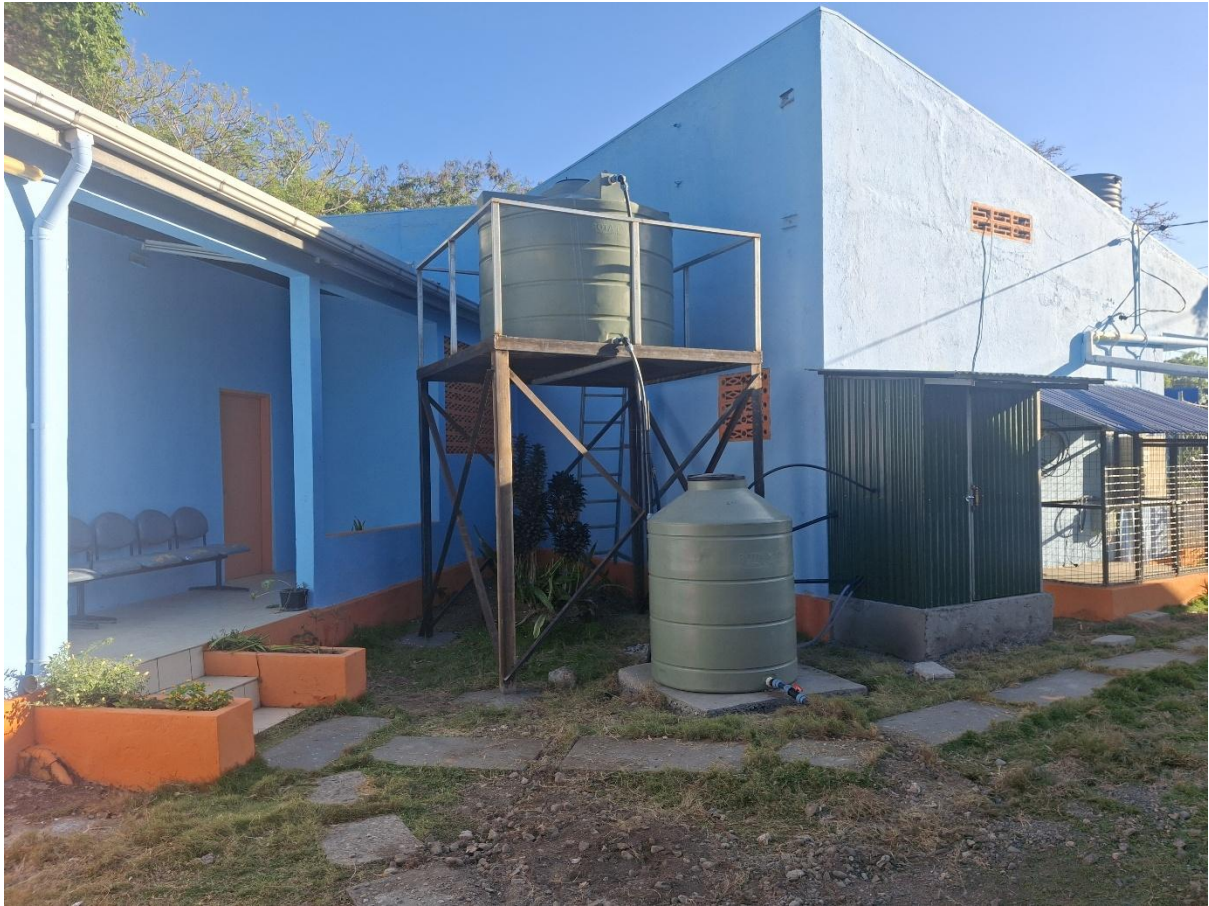
The newly installed system, including shelter house, tucked out of the way in the corner.

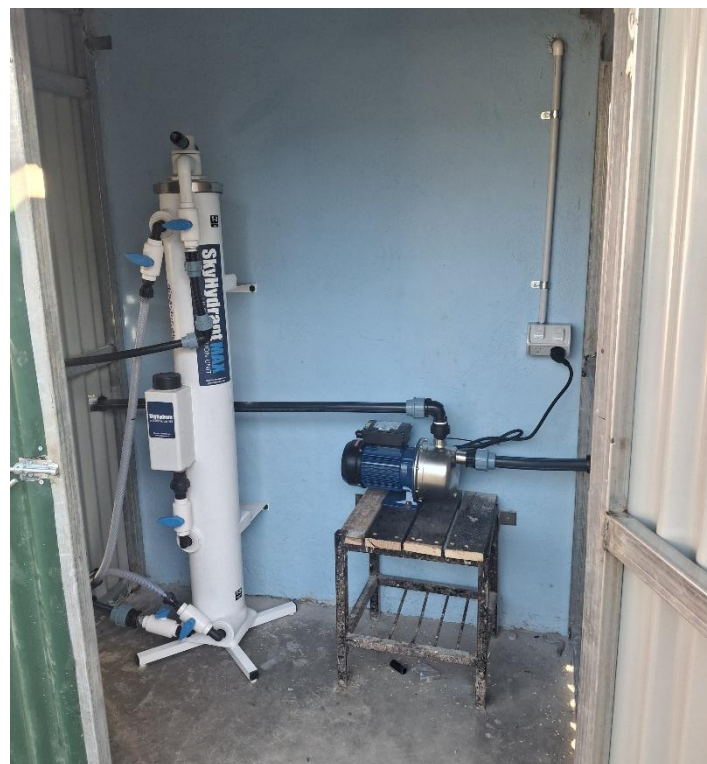
The SkyHydrant and pump in the shelter house.

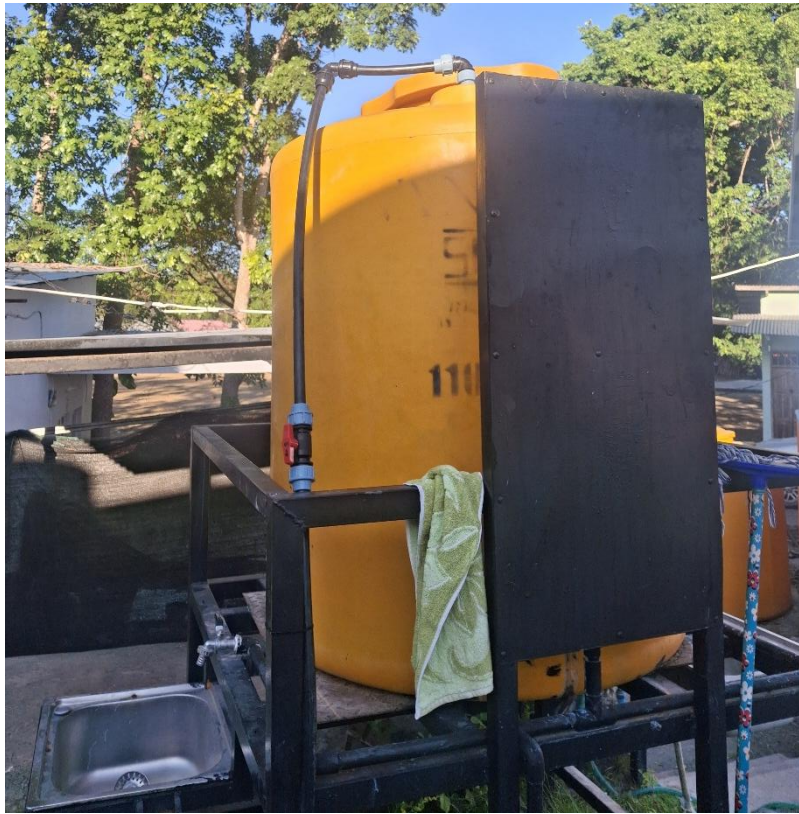
The Profile tank with supply line and tap, and new taps to the basins.

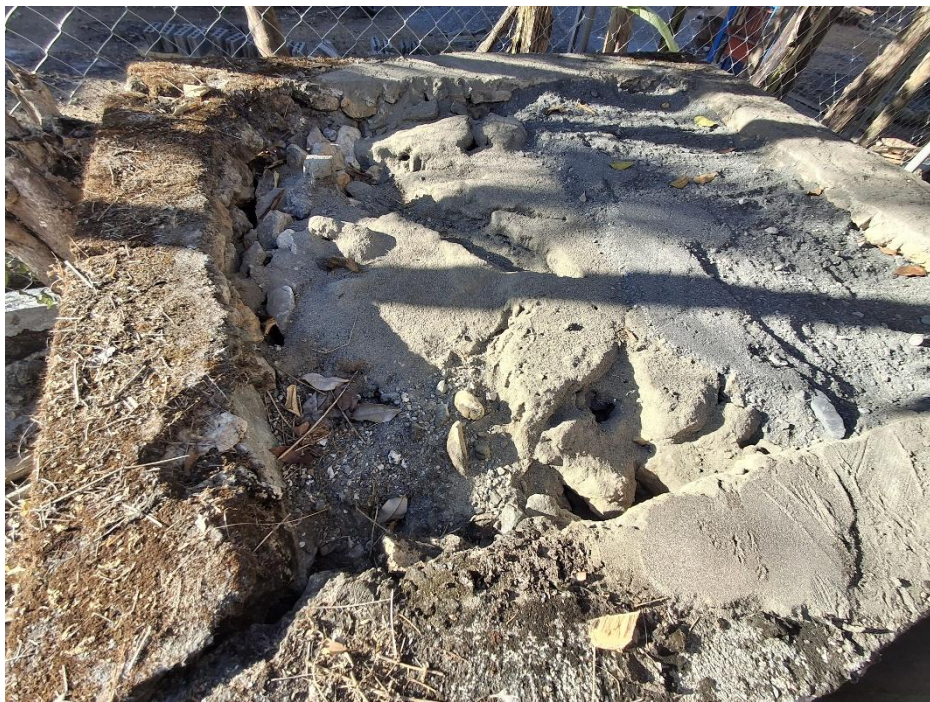
The base for the toilet tank. The space had been filled with large stones, but then sand laid on top, with no barrier between the two layers. Consequently, the sand then dropped down between the stones creating a very uneven base for the old tank.

The toilet tank stand was refilled with coarse sand, which was then worked down between the stones. A 100mm concrete slab was then laid over it.

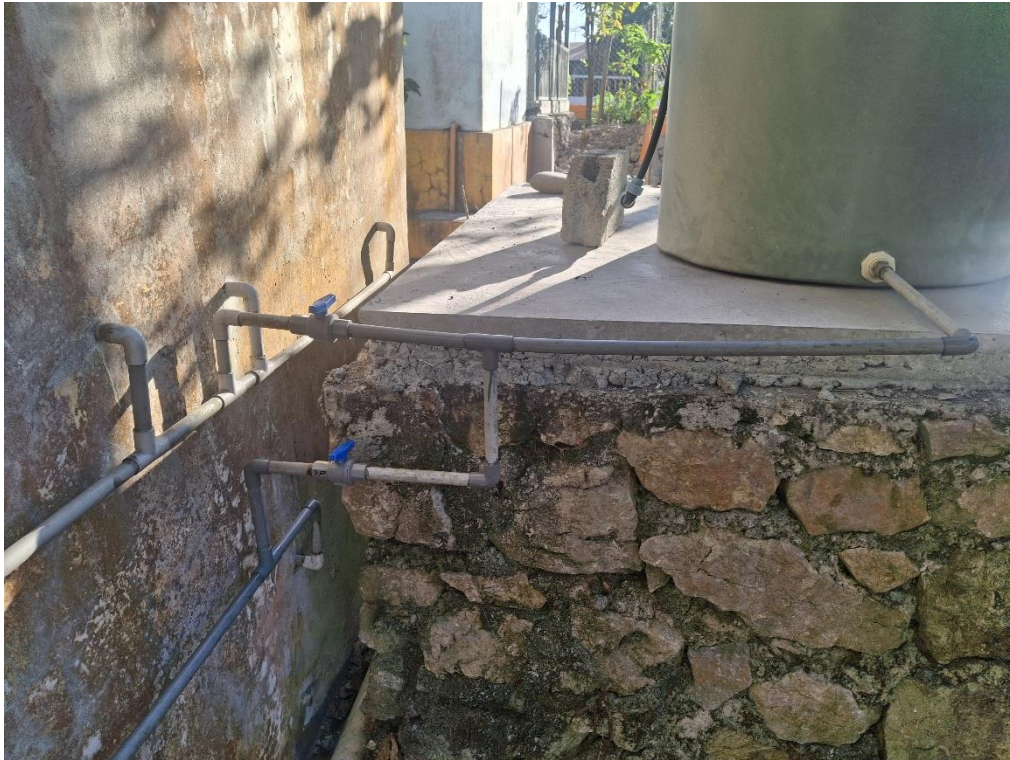
The new tank in position, and connected to the toilet wall taps and basins (top blue tap) and, first time ever, to the toilets (bottom blue tap).

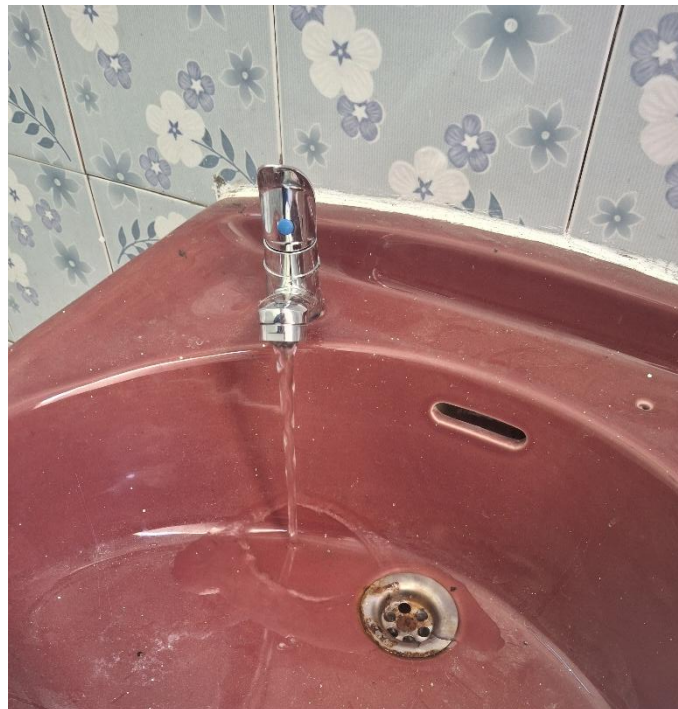
Water flowing to the handbasins, via new taps and new flexible lines.

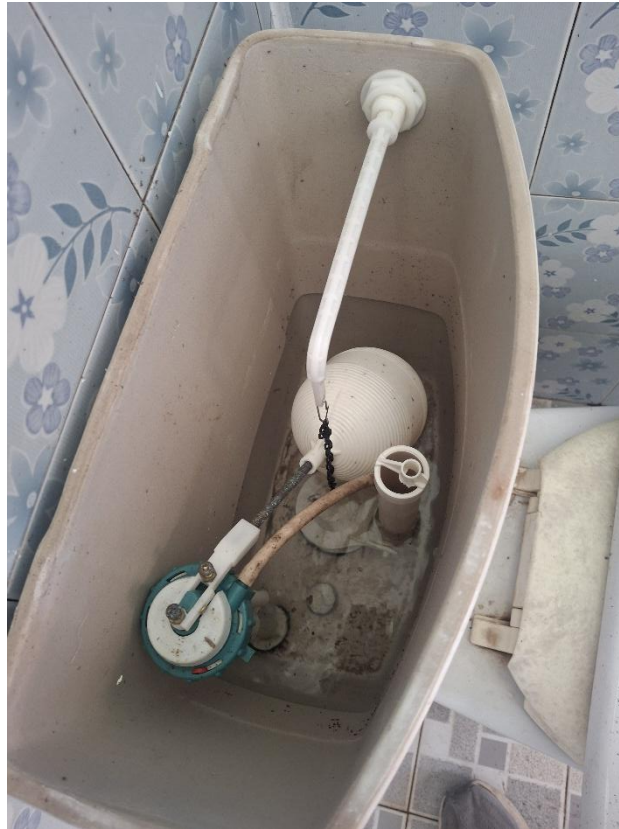
Toilet cistern filling
