Poverty reduction through Water, Sanitation

and Hygiene (WASH) Projects

December 2025 Newsletter

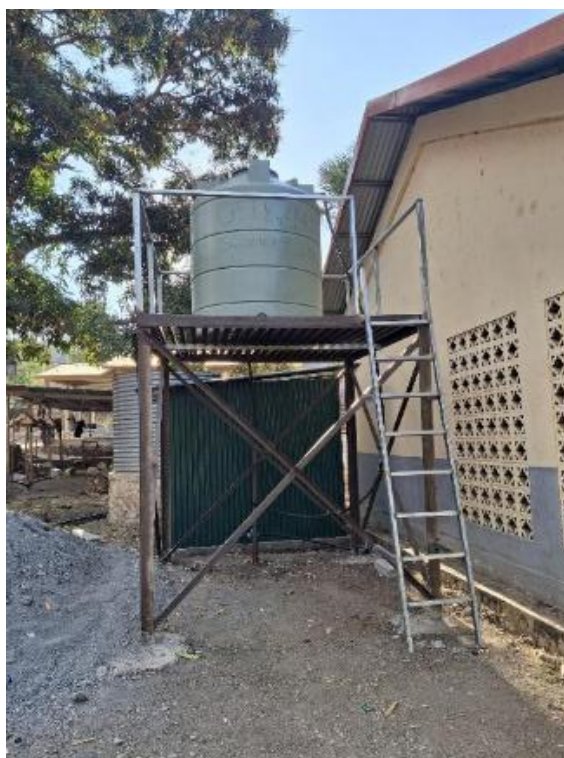
Leohitu School – SkyHydrant System & Bathrooms

*The “dirty water tank” installed on the tank stand, with ladder and safety rails.
In the green shed is the pump and SkyHydrant filter system.*

- 600 m poly pipe line from spring; new tank stand; SkyHydrant shelter and pump; absorption pit; electrical supply, new taps to water troughs and water connected.
- Existing gal tank taken off stand, cleaned out, and put back on stand.
- Rear toilets and troughs connected.
- Extra repairs: raised path, replaced lock, re-hung basins with new taps/flexible lines, taps at squat bowls.
- Main bathroom basin taps and taps and squatbowls connected and water running.
- School staff refresher training conducted on SkyHydrant operation & maintenance.
- Installed tap at sports ground.

NB: Main school bathroom handbasin drains remain broken, undermining hygiene and risking sustainability of the system. Waste water being collected in buckets. (May be problem locating suitable fittings in T-L.)

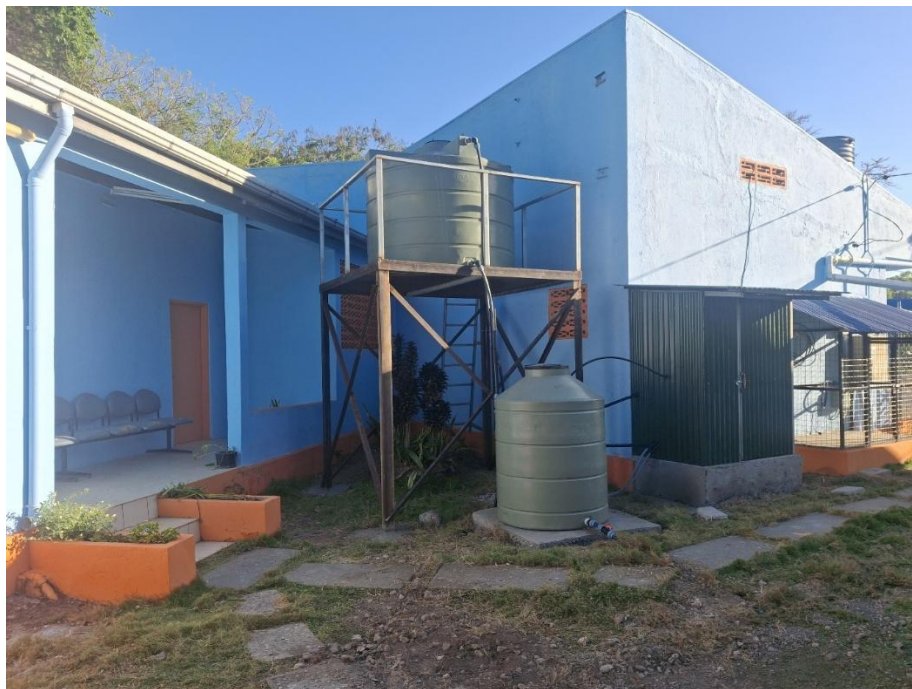
Balibó Community Learning Centre (CLC) – SkyHydrant Water System

The newly installed system, including shelter house, tucked out of the way in the corner. Again, in the green shed is the pump and SkyHydrant filter system. Water is pumped up o the “dirty water” tank, then gravity feeds back through the filter system into the “clean water” tank in the foreground.

- Shelter house, pump, SkyHydrant installed. System commissioned
- Existing galvanised tank used as pre-holding, pumped then to 3,200 L dirty tank.
- Dirty tank gravity-fed through SkyHydrant into 1,200 L clean tank, tied into existing distribution for clinic, kitchen, volunteer house.
- Dirty tank also connected to Profile tank (900 L) for general washing/watering and new 600 L toilet block tank.
- Toilets and handbasins in toilet block connected to the new tank.
