*Poverty reduction through Water, Sanitation*

*and Hygiene (WASH) Projects*

## July 2026 Newsletter

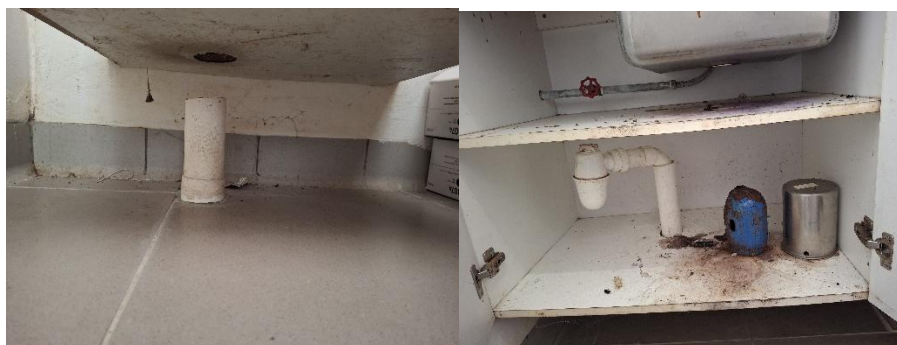
*Basin drains not connected*

- Replace roof ridge capping
- Install SkyHydrant, “clean water” tank & shelter house, including their concrete base slabs
- Test for water quality
- Connect clean filtered water to hospital buildings
- Connect town water to toilets and World Vision handwash station
- Install taps and basin drains through hospital buildings

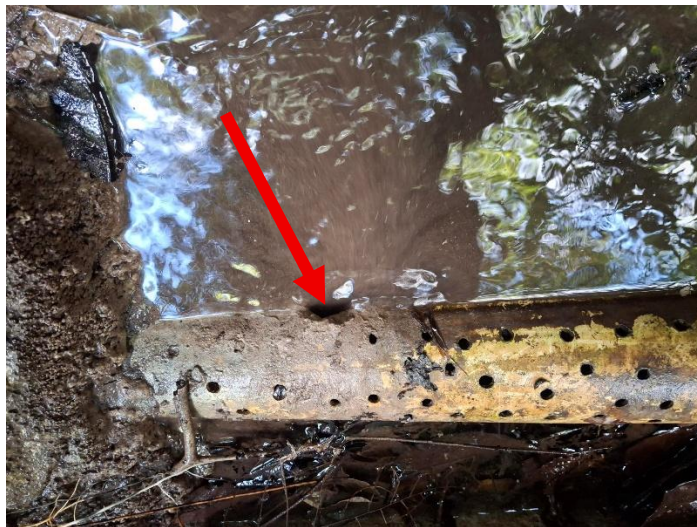
- Conducted a stocktake of water supply materials in our container at Belola school
- Inspected the Lotan village water supply system from spring to main tank, to determine cause of low flow. (Long walk up steep hills). Work needed at the water entry, as well as repair to several broken pipe joints.

*Large hole in entry strainer pipe (red arrow) and inlet holes blocked below water line*

- Repair water inlet works at spring
- Repair and re-connect several places along the pipe of the existing water supply line, including draining any silt in pipe.
- Test for water quality
- Construct aerial ropeway over river to western side of river
- Extend pipe over river via aerial ropeway, and connect to existing gal pipe

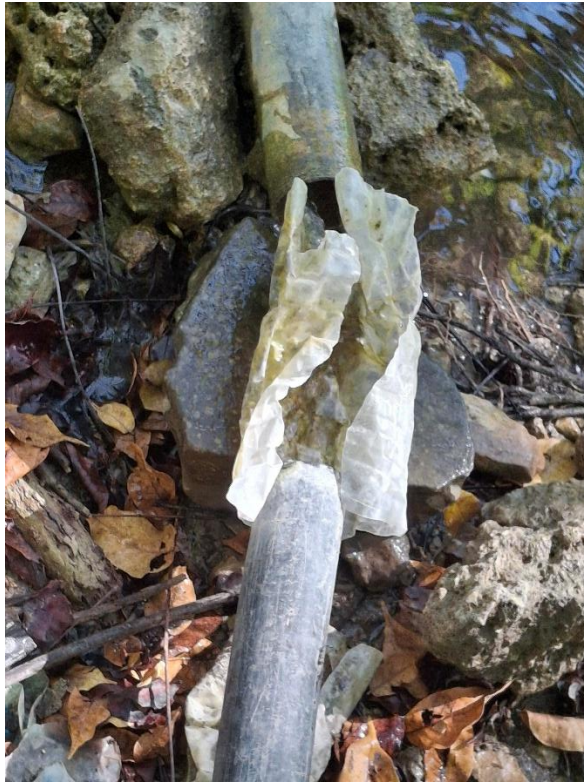
*Plastic water bottle transferring water between pipe sections*

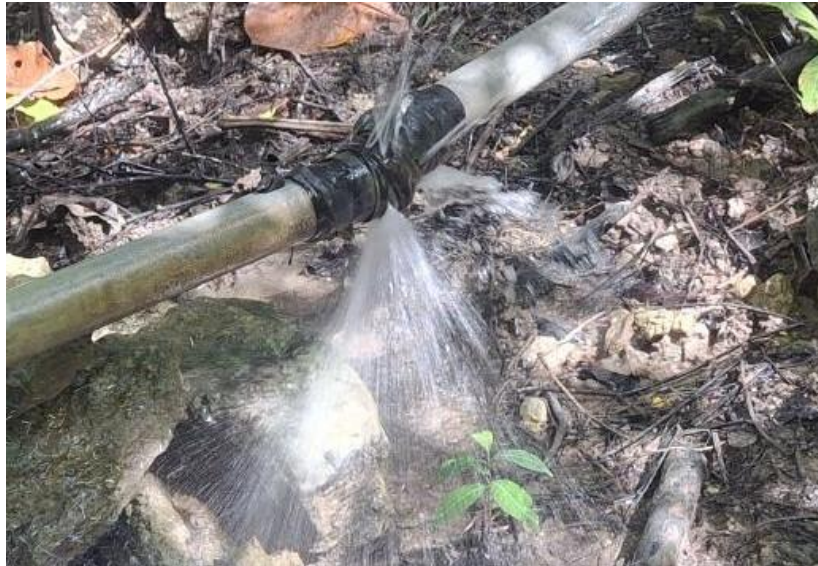
*Ineffective tyre inner-tube joint*

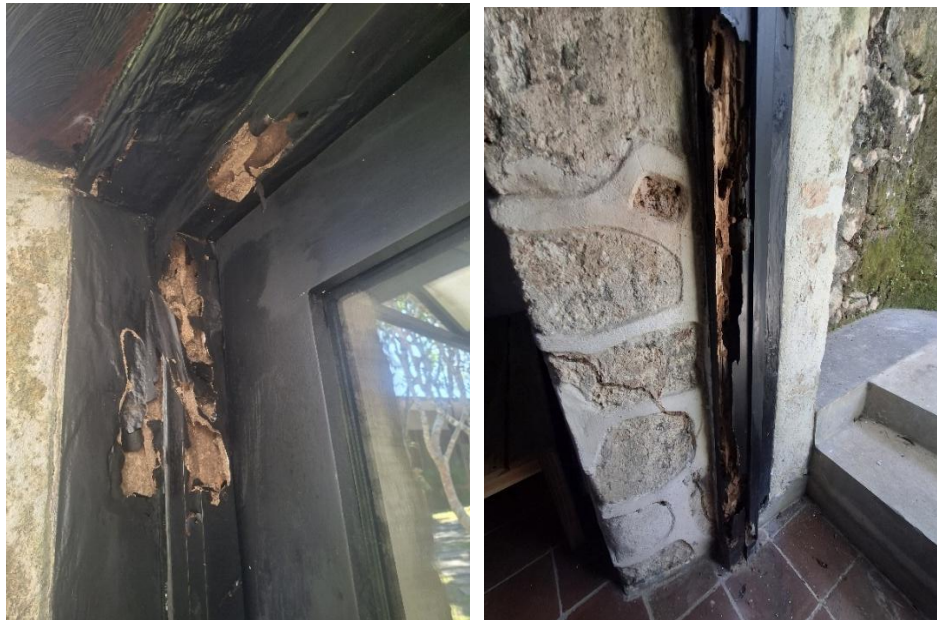
- Inspected the Balibo Primary school's damaged concrete verandah post and provided repair recommendations
- Conducted detailed inspection of white ant damage at Balibo Fort Museum and provided lengthy photographic report. Also sprayed white ant killer on all visible white ant evidence.

*Severe white ant damage in door frames at the Museum*
